UC Santa Cruz building seismic ratings
Thimann Laboratory

CAAN #7116
 568 Steinhart Way, Santa Cruz, CA 95064
 UCSC Campus: **Main Campus**

DATE: 2018-12-30

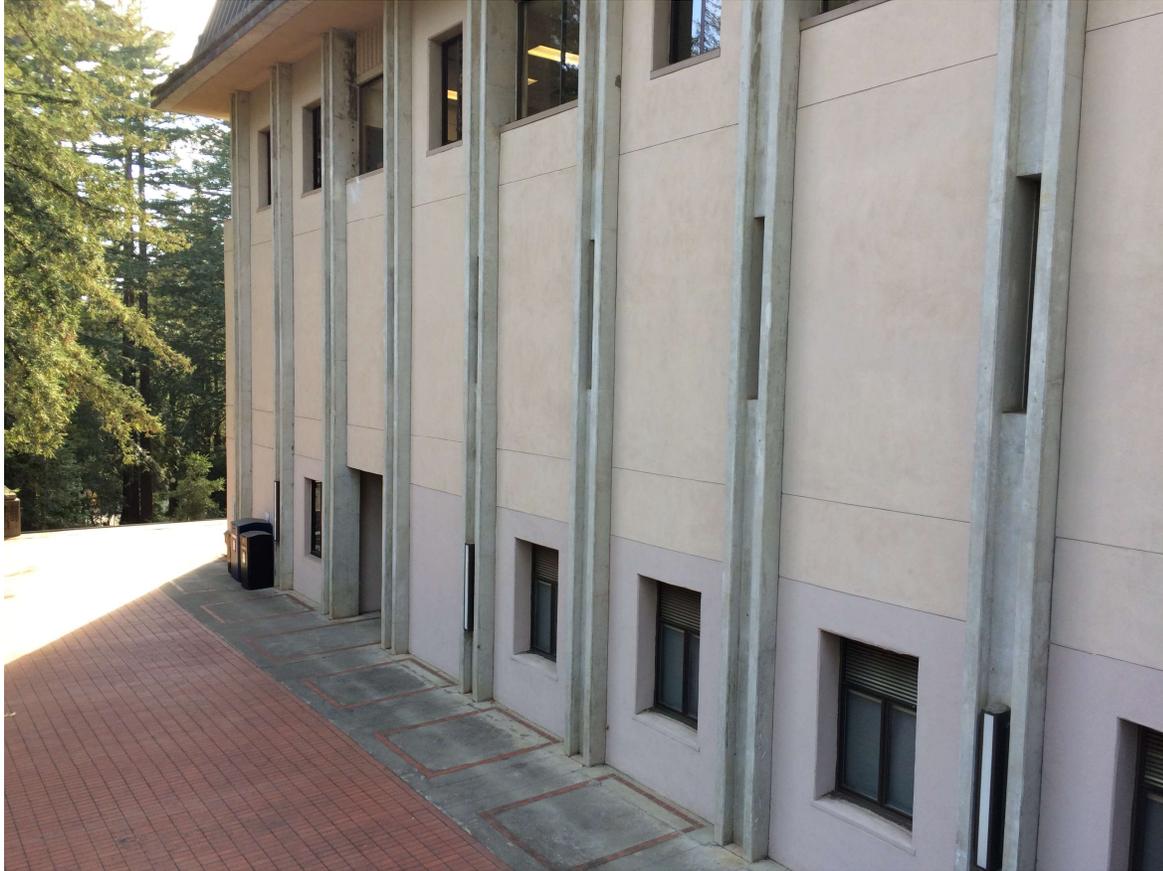
East elevation

The following deficiencies are based on review of original structural drawings for the building from 1964. A letter from 1989 indicates that retrofit work on the building was in progress at that time. However, UCSC has no record of retrofit drawings and is not aware of any additional visual observation of retrofitted items in the building. For the purposes of this rating, we assume that these deficiencies have not been addressed. If subsequent investigation by UCSC indicates that some or all of these deficiencies have been addressed by retrofitting, this rating should be updated to consider the benefits of the provided retrofitting. Also, during our site visit, we observed that the openings in the precast wall panels at the façade do not match the original structural drawings. For example, in locations where the drawings show the wall set back from the face of the building, the wall currently does not step back. Also, window openings are smaller than shown in the drawings.

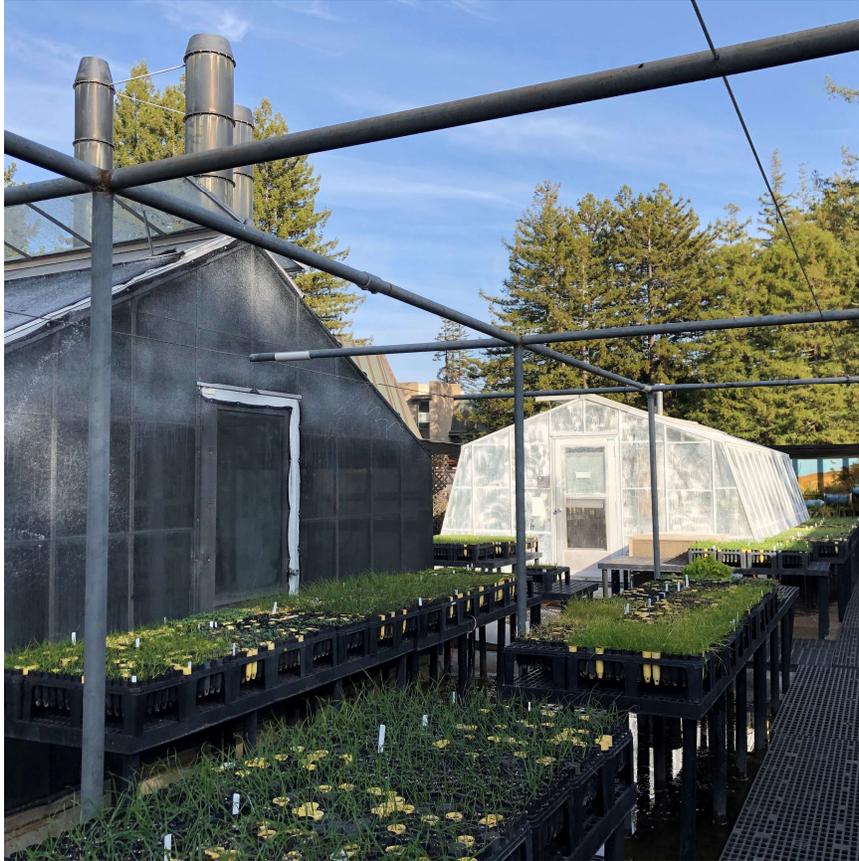
Roof greenhouses

It can be seen from satellite imagery that various penthouse and greenhouse structures have been added to roof of the Lab building. These have not been reviewed or assessed. It can also be seen that a bridge connecting to Sinsheimer has been constructed that appears to closely abut the building; we did not observe whether the bridge is connected to the building.

Penthouses and greenhouses that are presumably of lightweight construction have been added to the roof since its original construction.
