DATE: 2019-06-28

UC Santa Cruz Building Seismic Ratings
East Field House North Building

CAAN #7119

418 Hager Drive, Santa Cruz, CA 95064

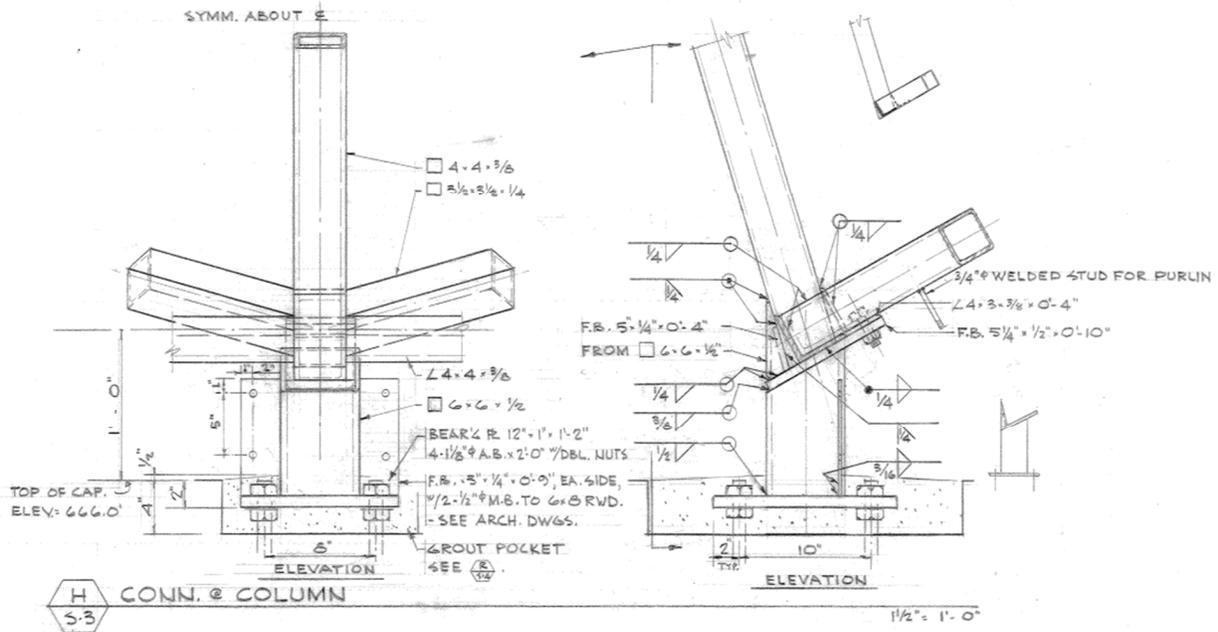
General Purpose Room Roof Truss Connection to Top of Concrete Column

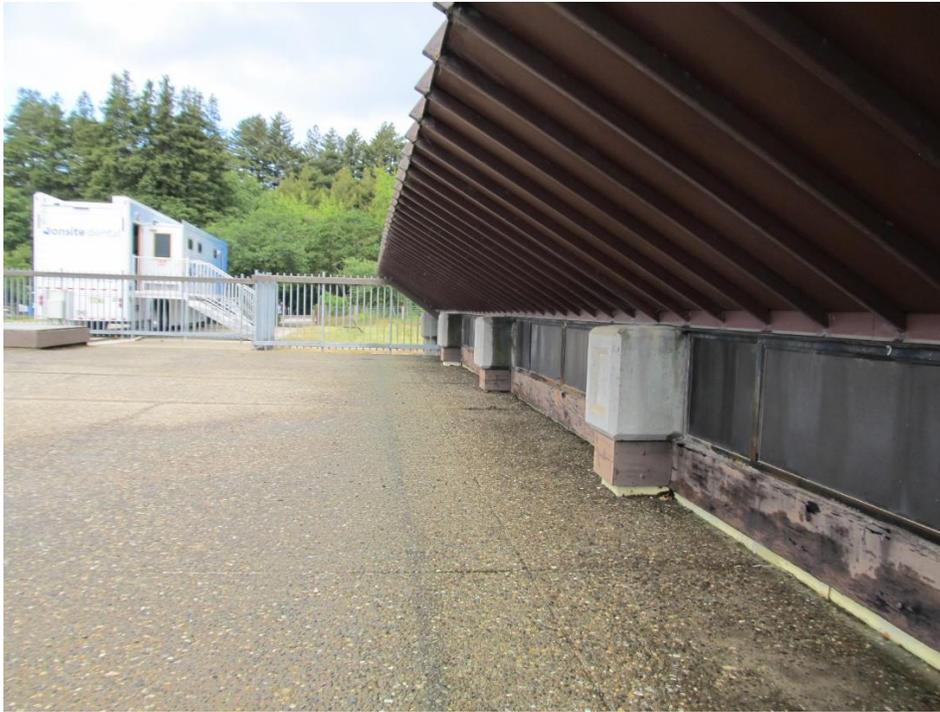
The building is assigned a Seismic Performance Level rating of IV. The short columns in between at the clerestory windows at the roof of the general purpose room have adequate capacity to resist the demands, and the lack of a compliant seismic separation at the adjacent building to the south is not considered to be a significant enough deficiency to reduce the rating as the concrete levels align.

South Elevation of Clerestory Windows at General Purpose Room
(Looking Southwest from South Roof Terrace)

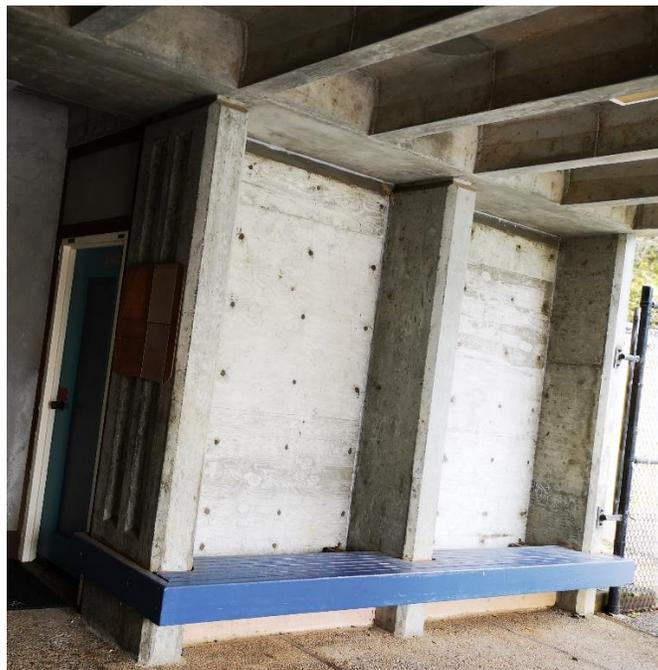
In 1988, a 12'-0" long 9" thick concrete shear wall was added to the east perimeter of the north rectangular section during a seismic upgrade, which helped reduced inherent torsion due to the concentration of N-S direction shear walls towards the east side of the building.

Added Shear Wall in 1988 Seismic Upgrade
(Looking Northwest)

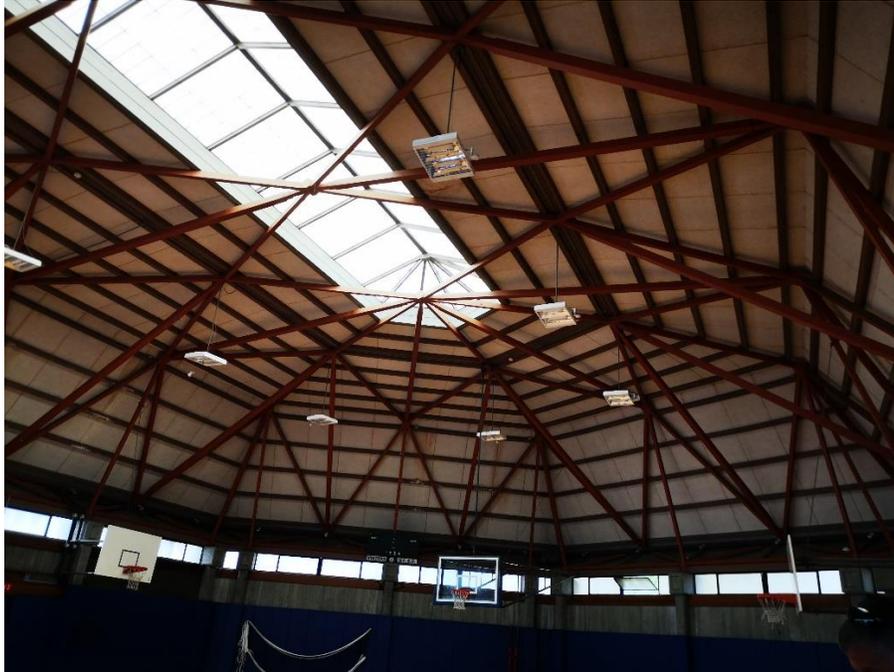
The space truss roof system appears to be in good condition and is positively anchored down to shear walls lines below. Due to its relative light weight and flexibility compared with the concrete below, the building will act as a podium structure so that the dynamic base of the steel truss assembly will be effective the concrete terrace roof, and inelastic demands on the truss elements are anticipated to be limited.

Steel Space Truss in General Purpose Room

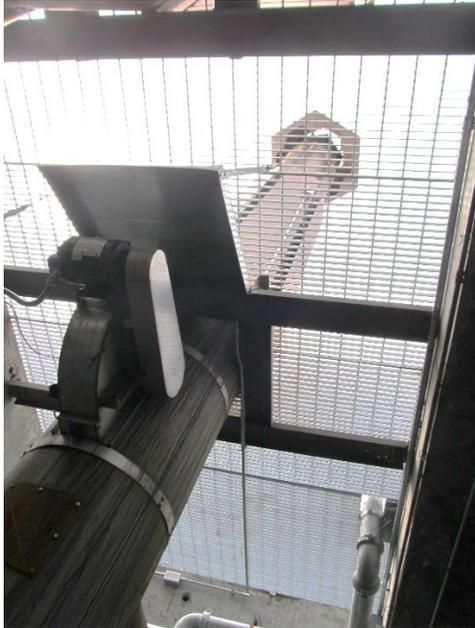
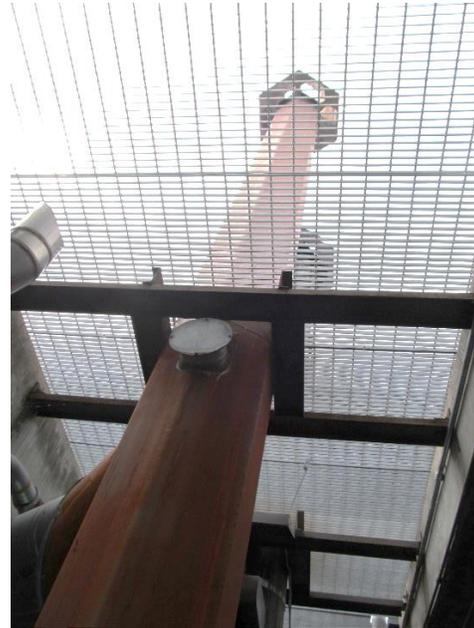
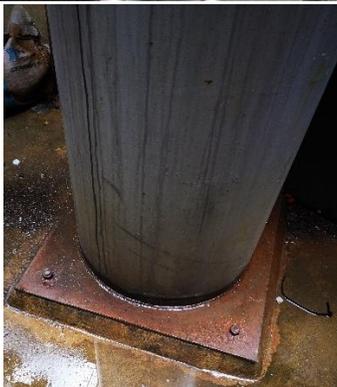
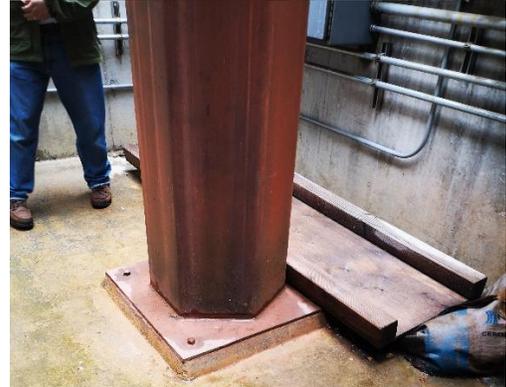
Steel Flues Extending Through Metal Grating and Base Connection
