UC Santa Cruz Building Seismic Ratings

Crown Classroom Building

CAAN #7155

624 Crown Road, Santa Cruz, CA 95064

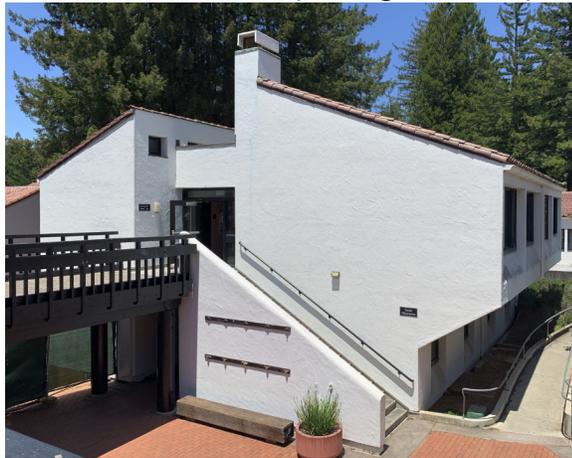
South Elevation (Looking Northwest)

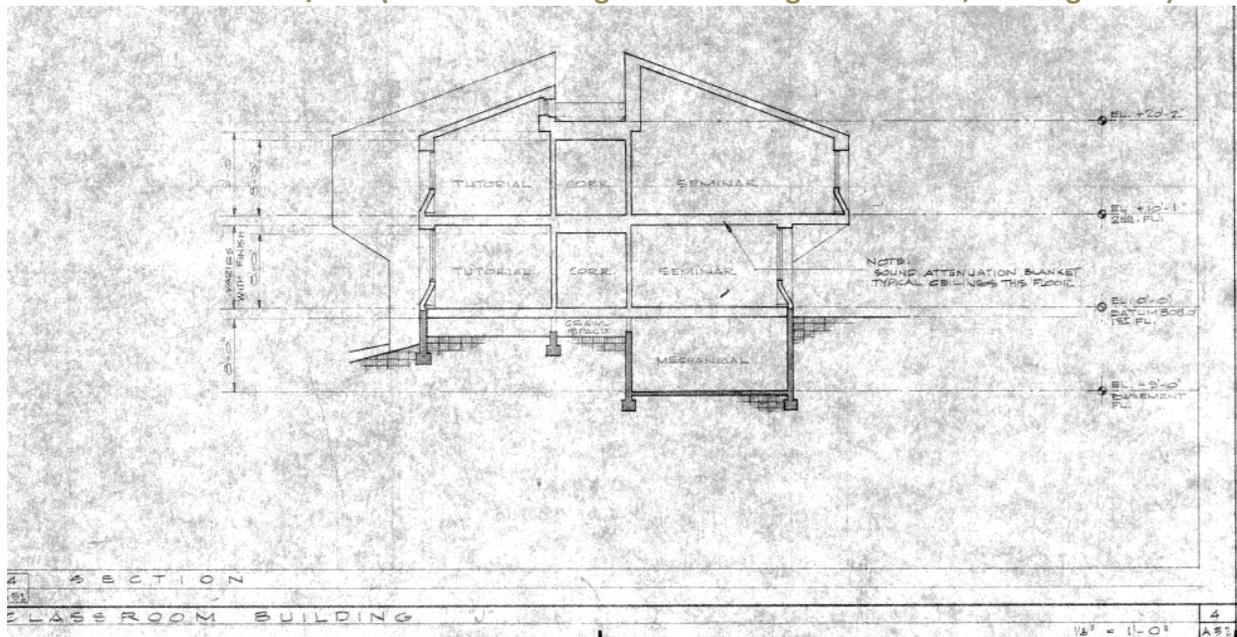
- The building has apparent vertical discontinuities in both directions and lacks a clear load path for loads in the longitudinal direction for the cantilevered areas where the second floor is wider than the first and the roof planes do not align.
- Connection details from floors to walls and floors to the foundation stem wall include cross grain bending.

Architectural Section 4/A32 (Shows Overhangs and Differing Roof Planes, Looking North)

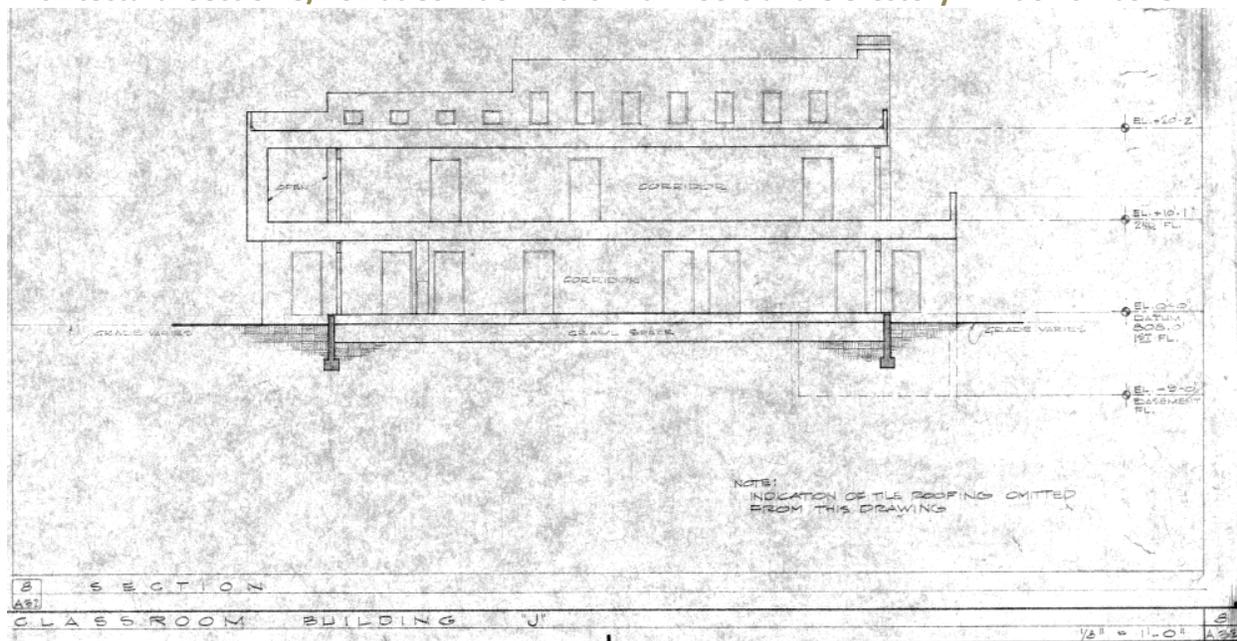
Architectural Section 8/A32 at Corridor Walls with Doors and Clerestory Windows Above

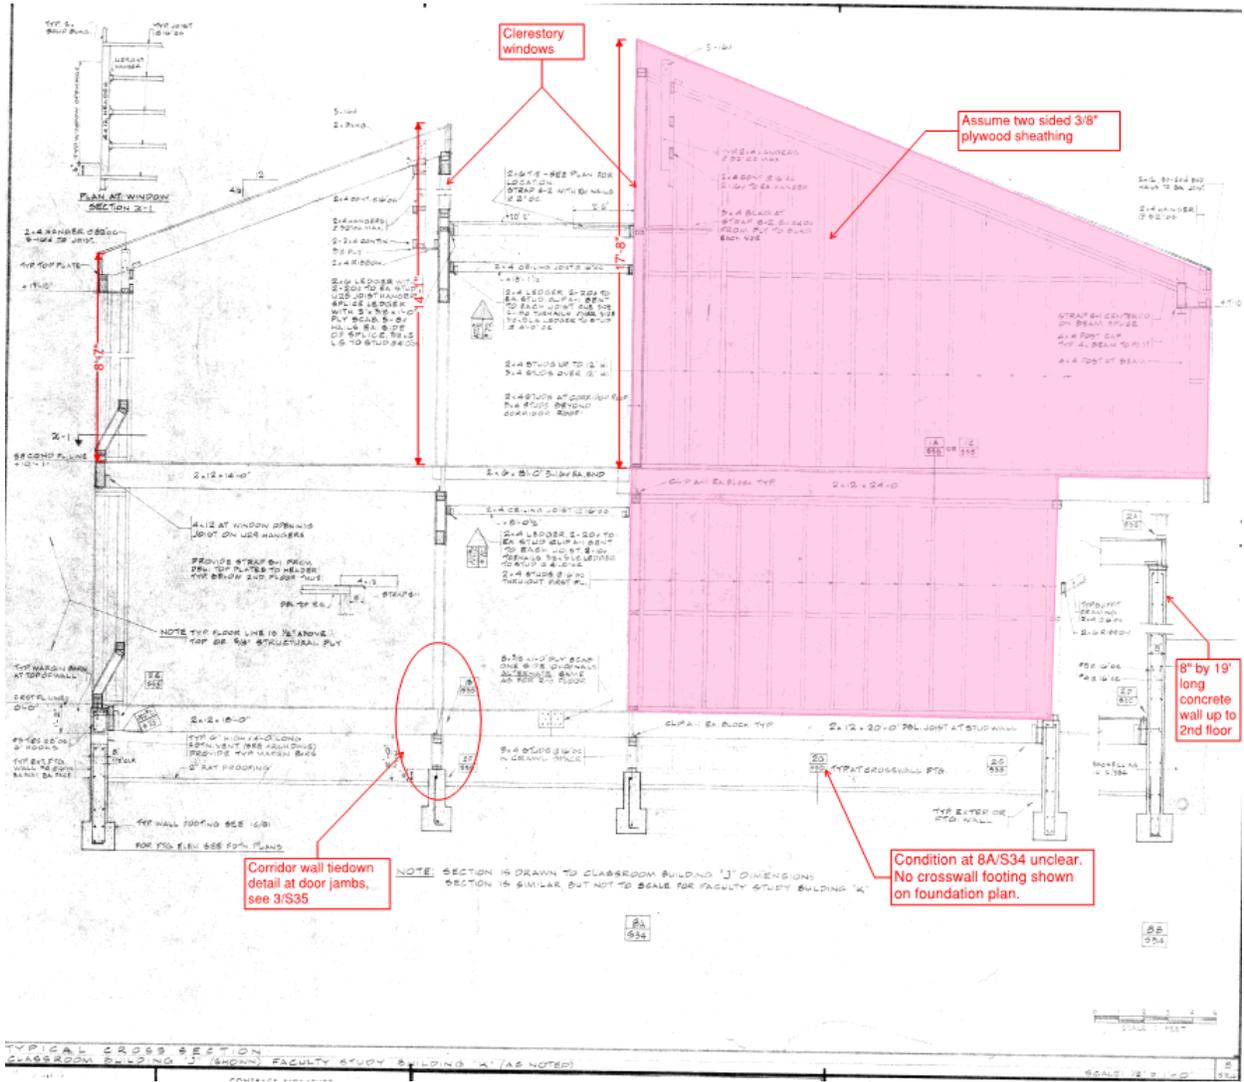
Interior Transverse Structural Building Sections 8A&8B/S34

- The transverse walls are wider at the upper floor, and lack straps and hold downs to resist overturning. While drawing notes that walls should have plywood sheathing, the drawings do not clearly show which walls are assumed to resist lateral loads. Not all of the transverse walls extend down to foundation transverse walls.

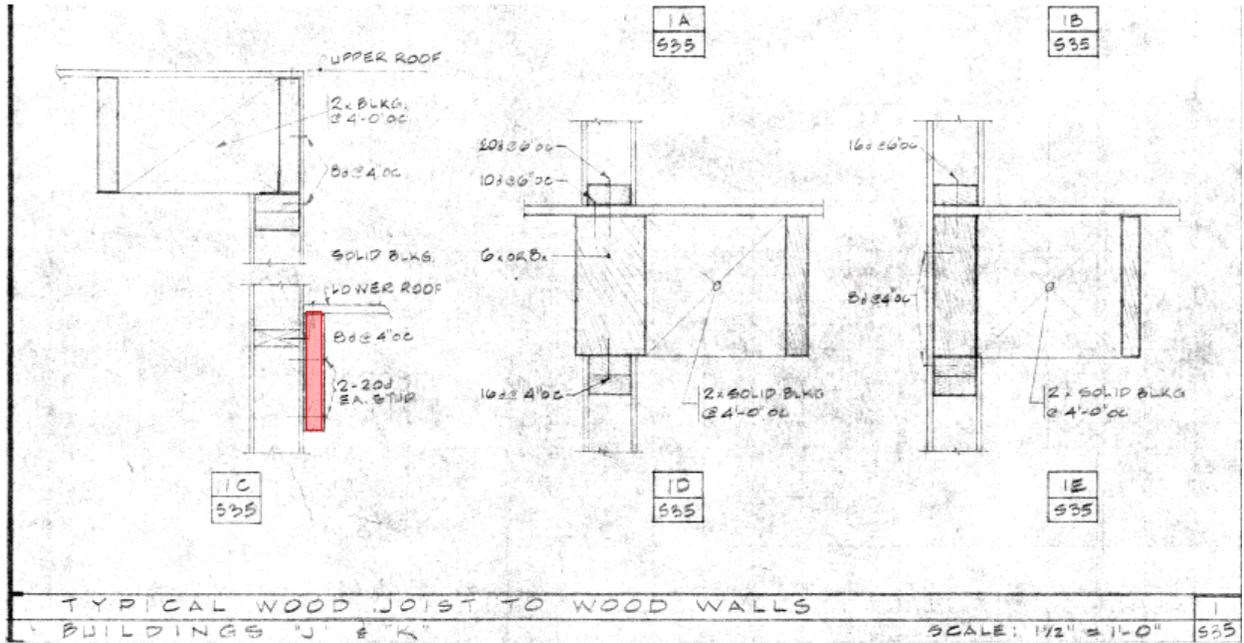
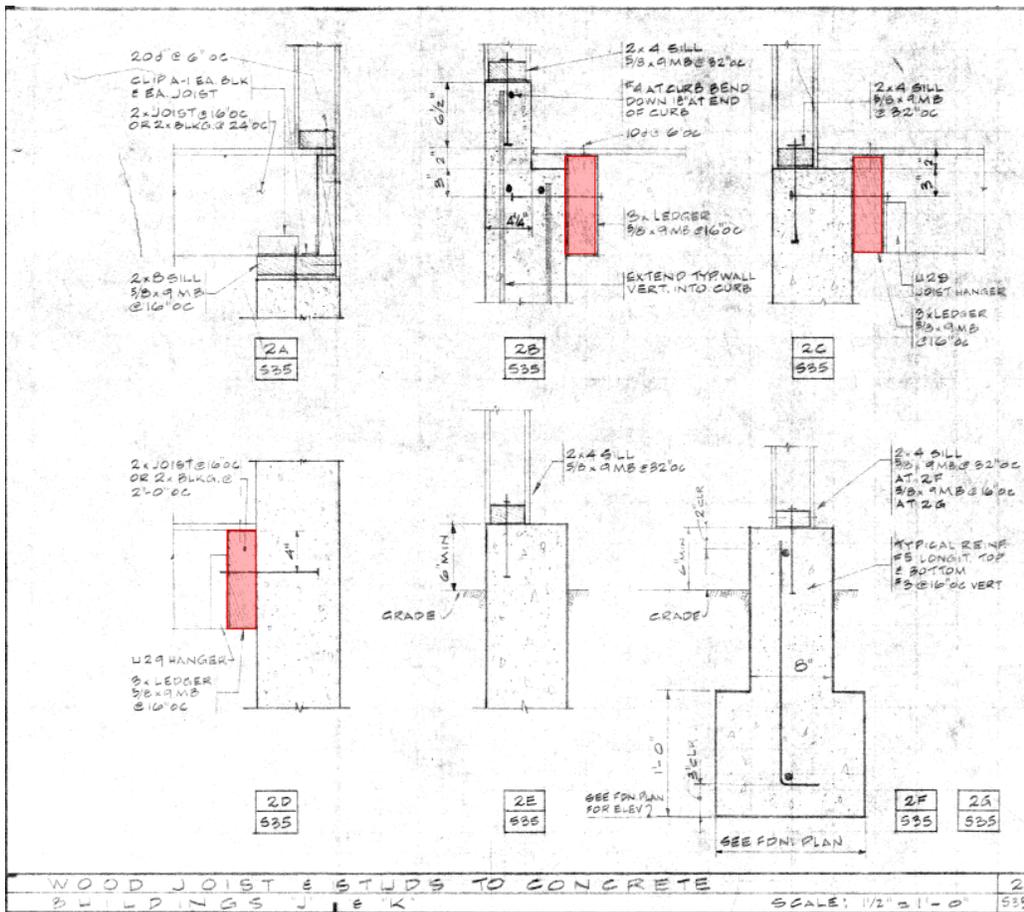
Cross-Grain Bending in Typical Details 1C, 2B, 2C, 2D/S35 at Connections from Corridor Roof to Wall and from Floor to Foundation Stem Walls

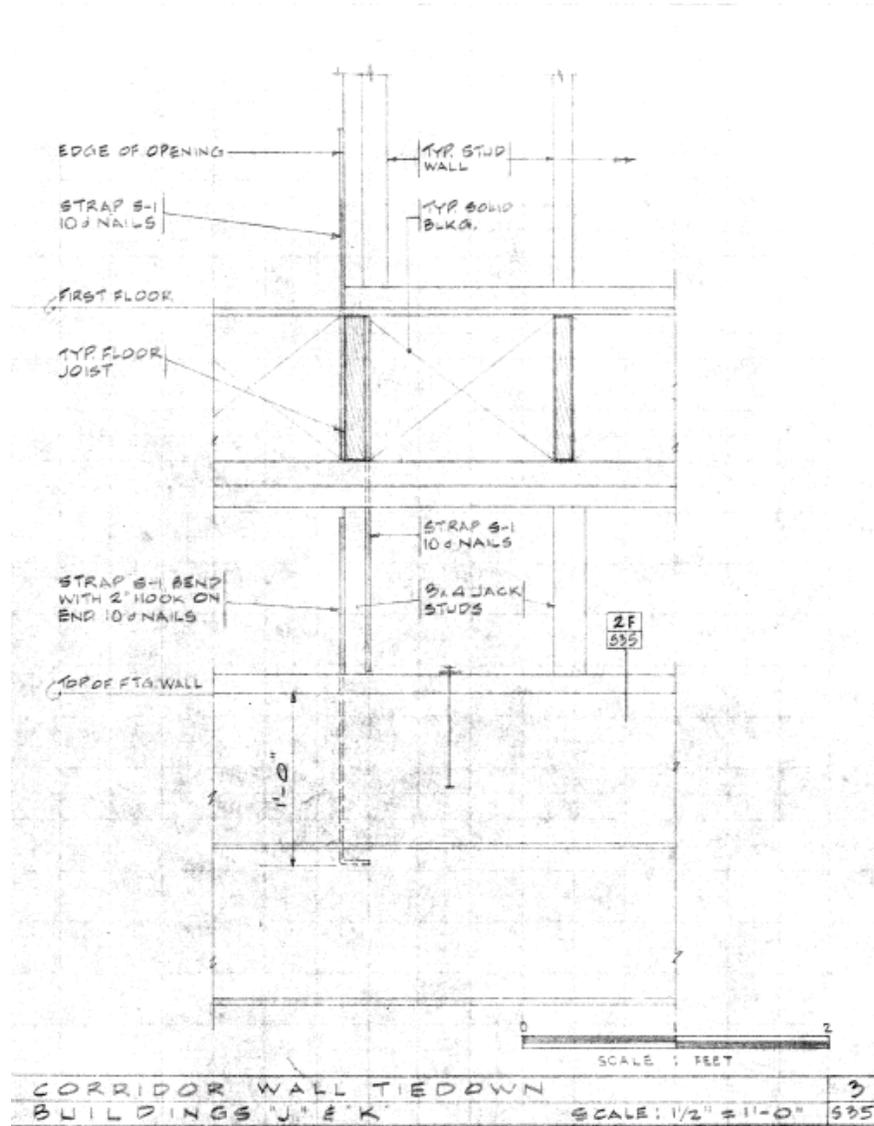
Connection Details at "Corridor Wall Tiedown" (at First Floor Door Jambes Only)

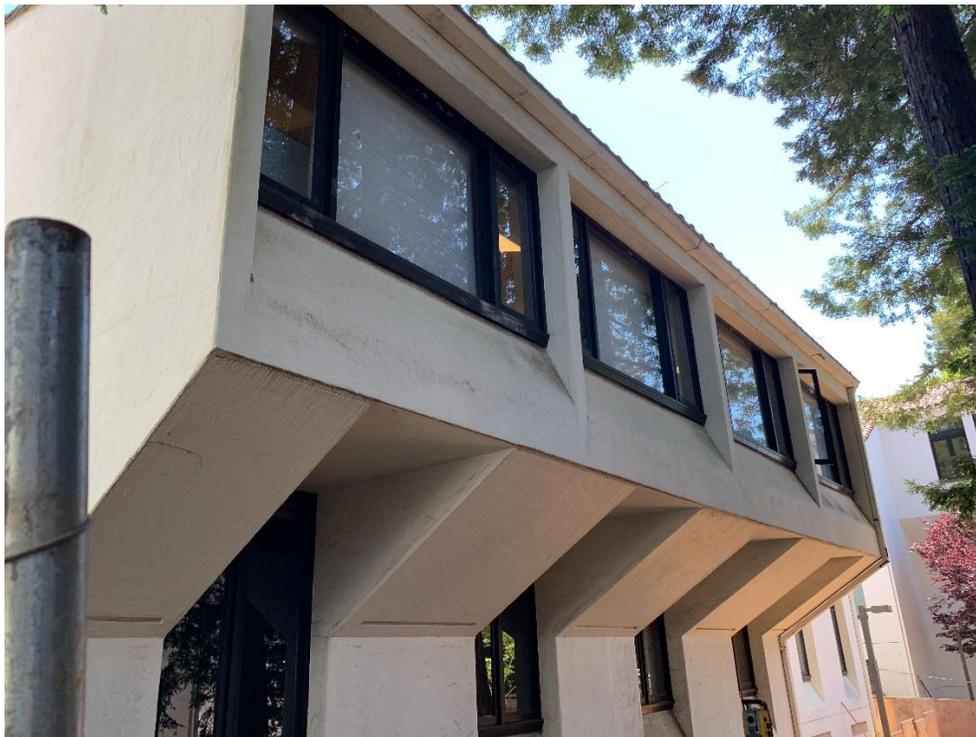
- It appears the original designer assumed the longitudinal loads could all be resisted by the central corridor walls. There is no clear load path from the outboard edges of the heavy tile roof to the 4x4 posts and down to the walls below.

Detail of Overhang at East Elevation (Looking Northwest)

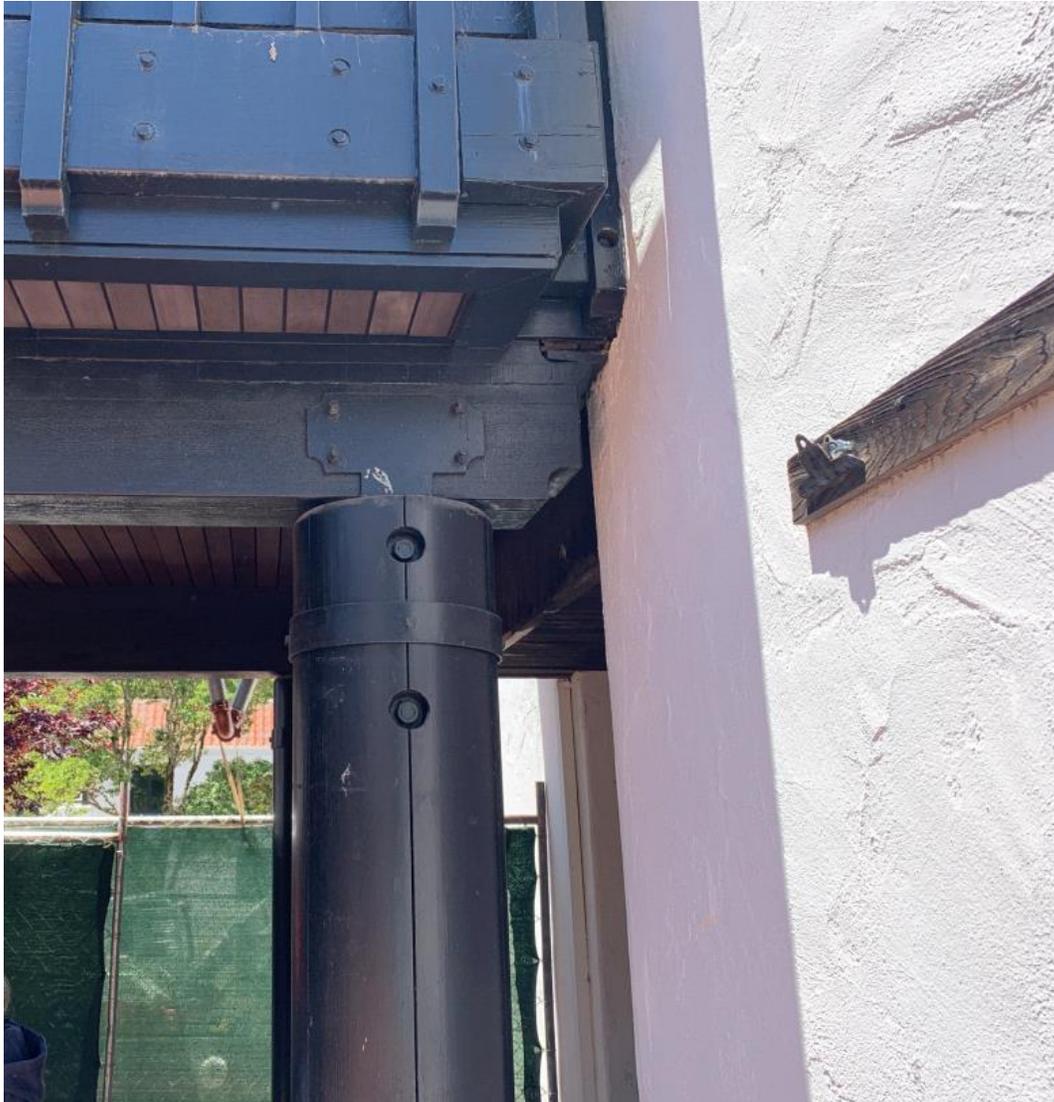
- There is a potential for pounding between the bridge structure and the stairs at the south end of the building.
- A Tier 2 deficiency-based analysis of the shear walls, transfer of loads to walls, transfer between floors, and foundation connections is needed to understand the capacity and performance of this lateral force-resisting system. Recommend additional field survey to confirm locations of plywood sheathing and foundation cross walls.

Close-up of Walkway Adjacent to South Elevation

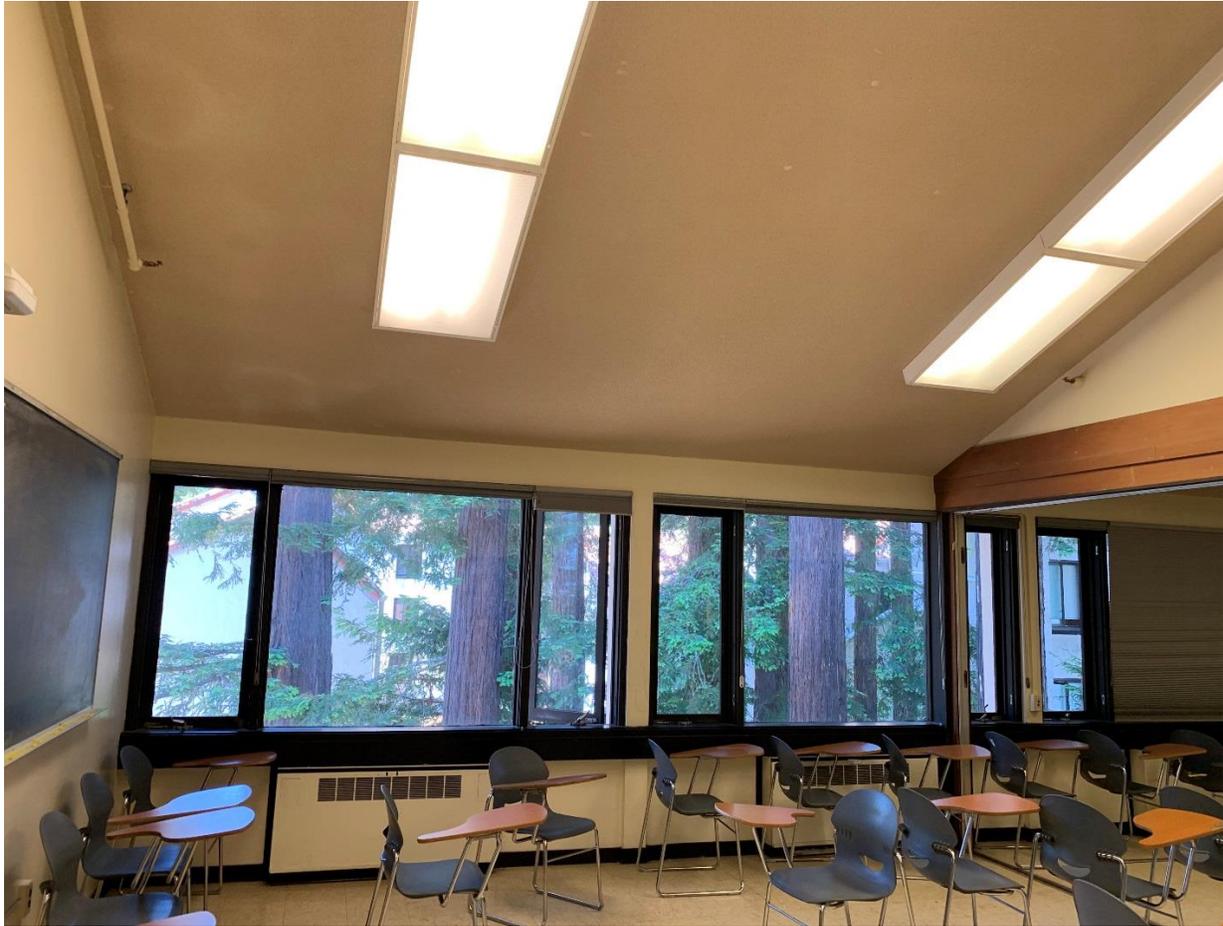
4x4 Posts Support Roof Loads at Second Floor (Looking West)

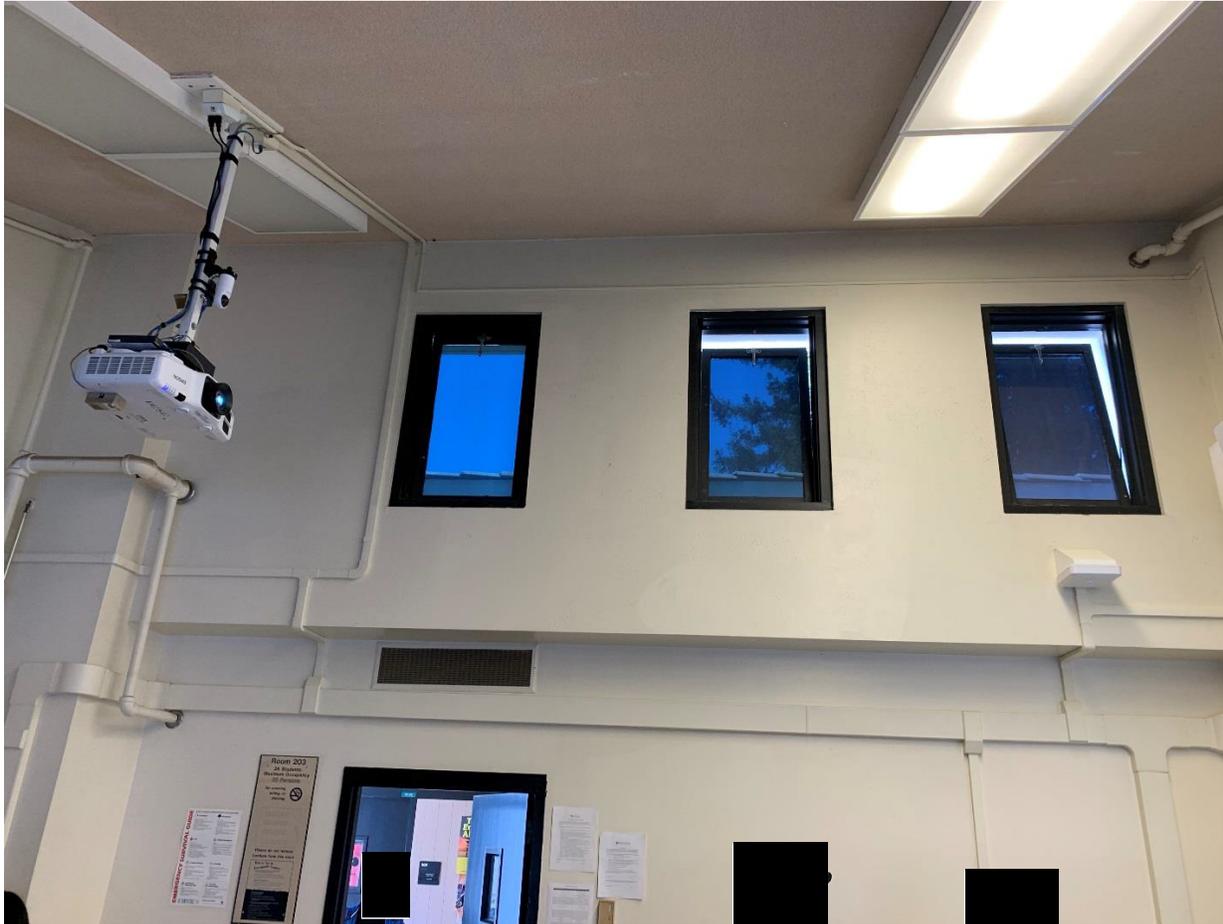
Overhead projectors were present in several classrooms. We recommend verifying that they are properly anchored. This building has what appears to be unrestrained Spanish tiles, including some adjacent to stairs and over adjacent footpaths. We recommend providing positive attachment for tiles (if not currently present) adjacent to stairs and walkways to preclude a life-safety concern.

Unsecured Projector, Clerestory Windows in Second Floor Classroom

We recommend performance of a Tier 2 evaluation to review the lateral force-resisting capacity of the wood shear walls, internal connections, floor-to-floor connections, and connections to the footings. Since the drawings are not clear regarding the location of plywood, we recommend that the walls be surveyed to identify plywood sheathing (single sided, double sided, or none). If the walls or connections are inadequate, connections could be strengthened, or supplemental lateral resistance could be added. Retrofits might include hold downs and straps between floors at vertical discontinuities. A clear load path should be provided for longitudinal loads at the perimeter. We assign the building to Priority Category B, as the retrofit of the building should be done when there are any plans for modifying or change of occupancy. Falling hazards reduction, such as the tile roofs adjacent to exits or footpaths and overhead projectors, should be addressed.
