DATE: 2019-06-28

UC Santa Cruz Building Seismic Ratings

Crown Faculty Wing

CAAN #7156

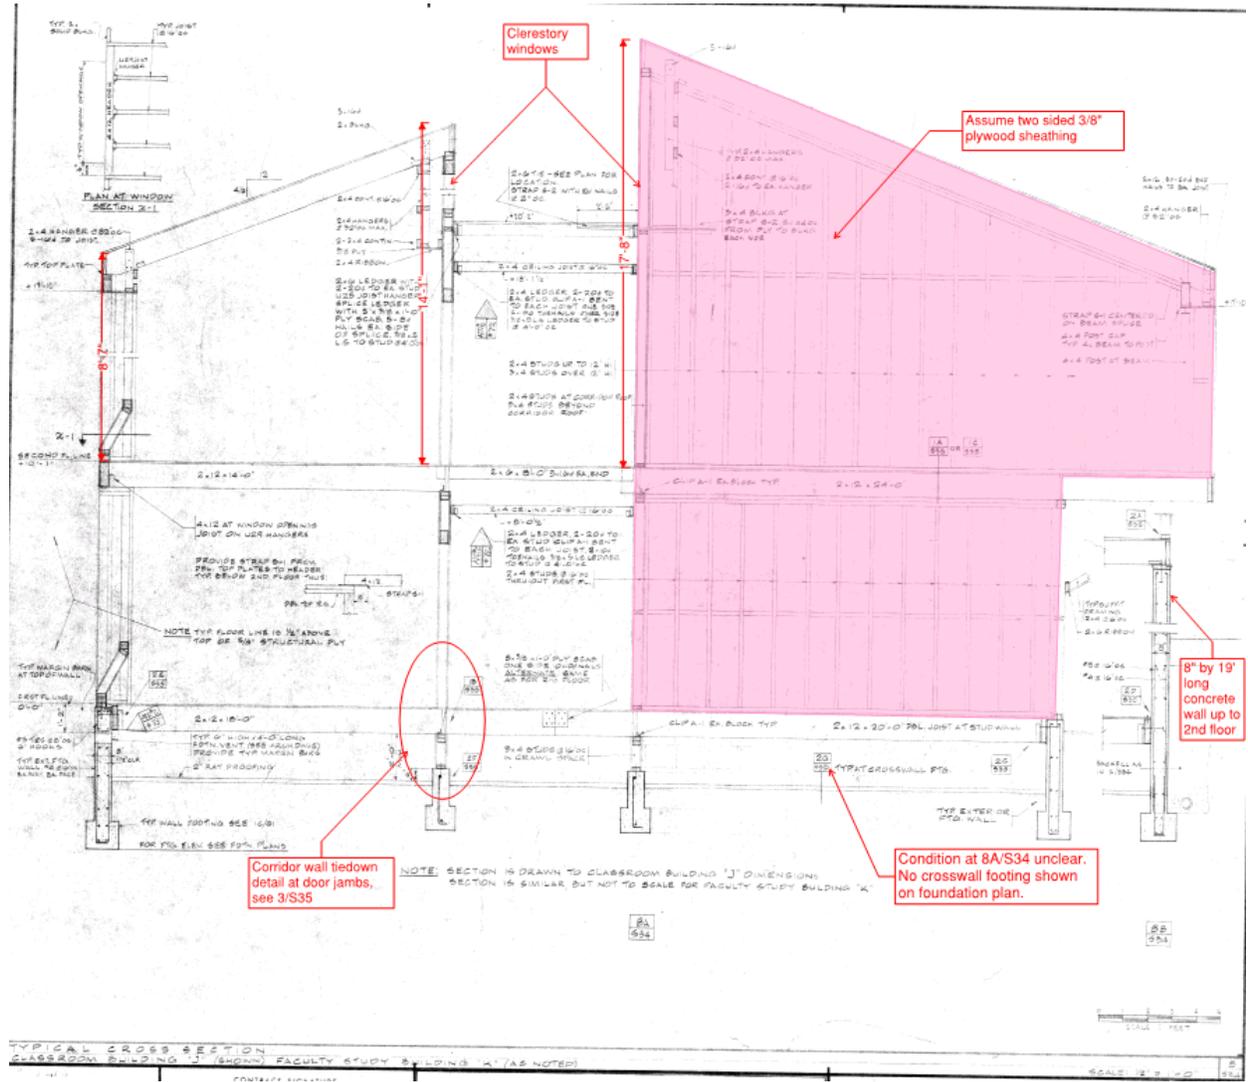
Interior Transverse Building Sections 8A & 8B/S34 (Similar) with Vertical Offset

- Connection details from floors to walls and floors to the foundation stem wall include cross grain bending.
- The transverse walls are wider at the upper floor and lack straps and hold downs to resist overturning. While drawing notes that walls should have plywood sheathing, the original drawings do not clearly show which walls are assumed to resist lateral loads. Not all the transverse walls extend down to foundation transverse walls.

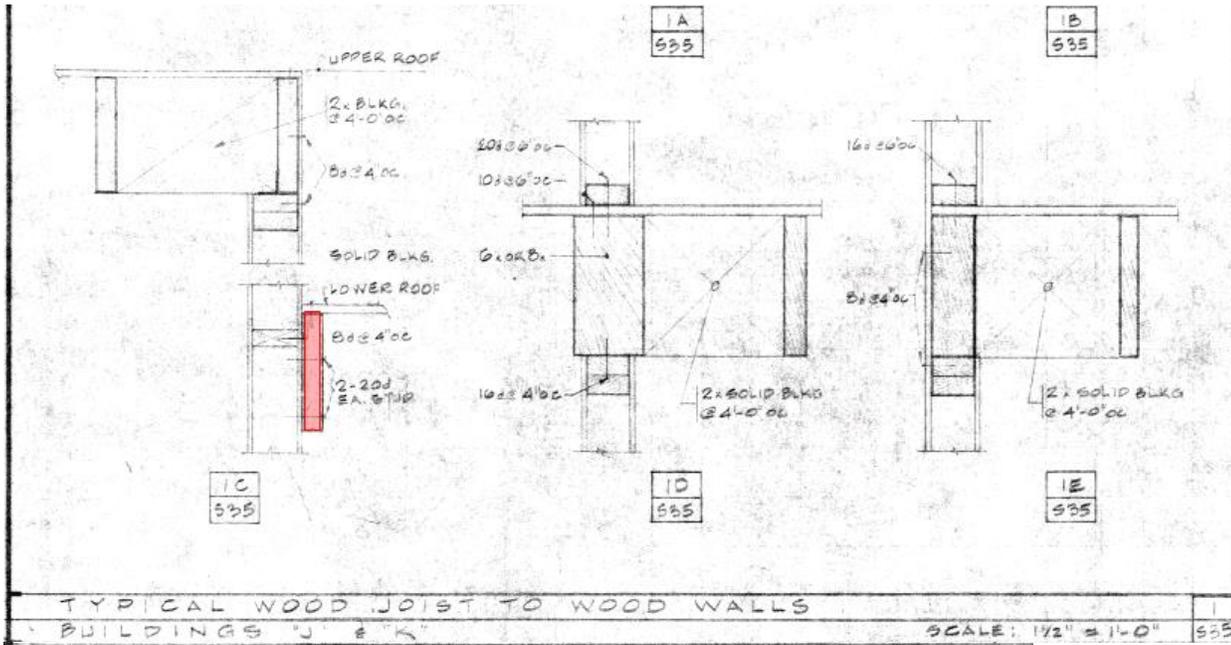
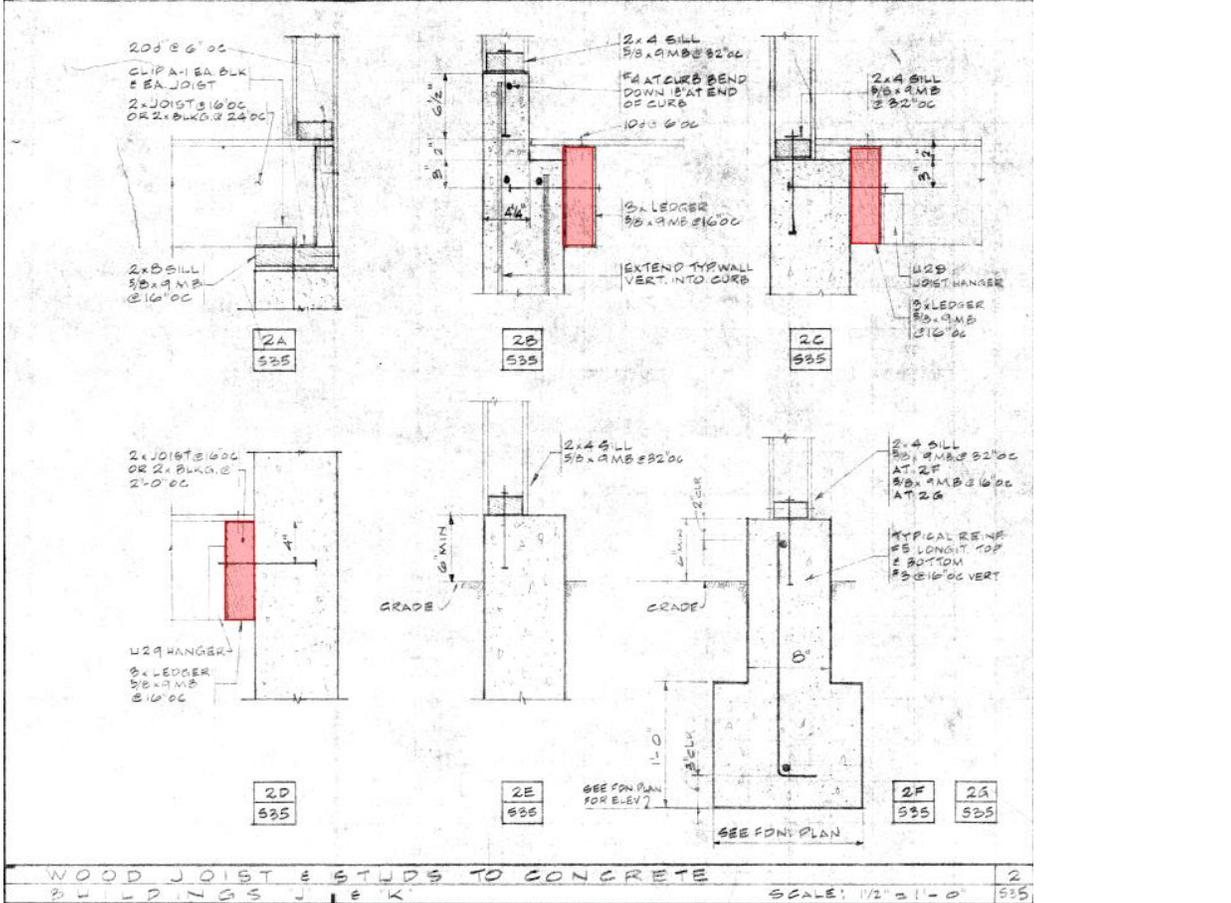
Cross-Grain Bending in Typical Details 1C, 2B, 2C, 2D/S35 at Connections from Corridor Roof to Wall and from Floor to Foundation Stem Walls

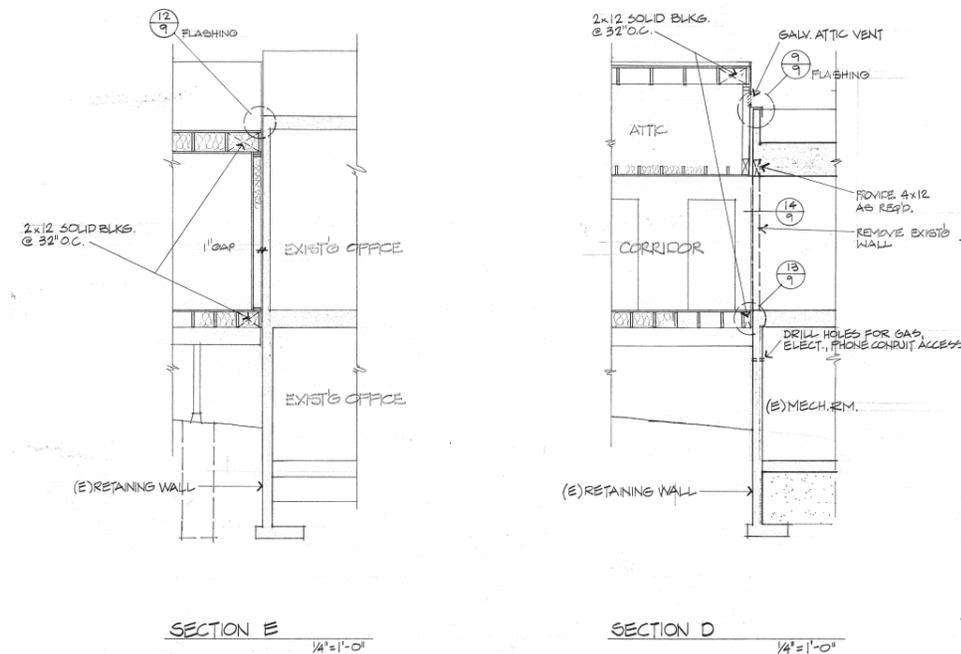
The 1985 addition shows a 1" separation to the original construction; this does not appear adequate to avoid pounding between the two sections. The drawings explicitly indicate which walls were designated as shear walls with a shear wall schedule. Lateral loads in the longitudinal direction are transferred from the roof diaphragm to the perimeter walls; lateral loads in the transverse direction are transferred to the three transverse walls, two at the east end and one near the west end. The perimeter walls on the north side are vertically aligned with the sheathed

Structural Section Between 1967 and 1985 Wings with 1" Gap

| | Description |
|---|---|
| C NC N/A U <input type="radio"/> <input checked="" type="radio"/> <input type="radio"/> <input type="radio"/> | <p>ADJACENT BUILDINGS: The clear distance between the building being evaluated and any adjacent building is greater than 0.25% of the height of the shorter building in low seismicity, 0.5% in moderate seismicity, and 1.5% in high seismicity. (Commentary: Sec. A.2.1.2. Tier 2: Sec. 5.4.1.2)</p> <p>Comments: Drawings show 1" gap between 1967 and 1985 construction. Height of addition at interface about 22 feet so gap inadequate, but floor levels align.</p> |

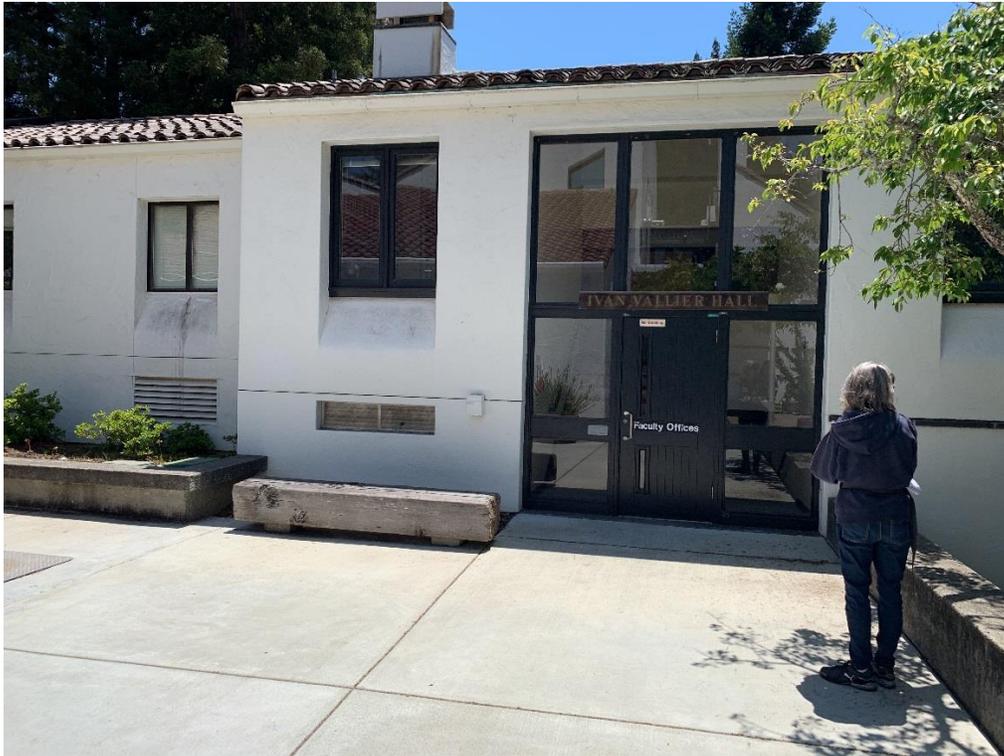
Detail of Overhang at North Elevation Original 1967 2-Story Faculty Wing (Looking Southeast)

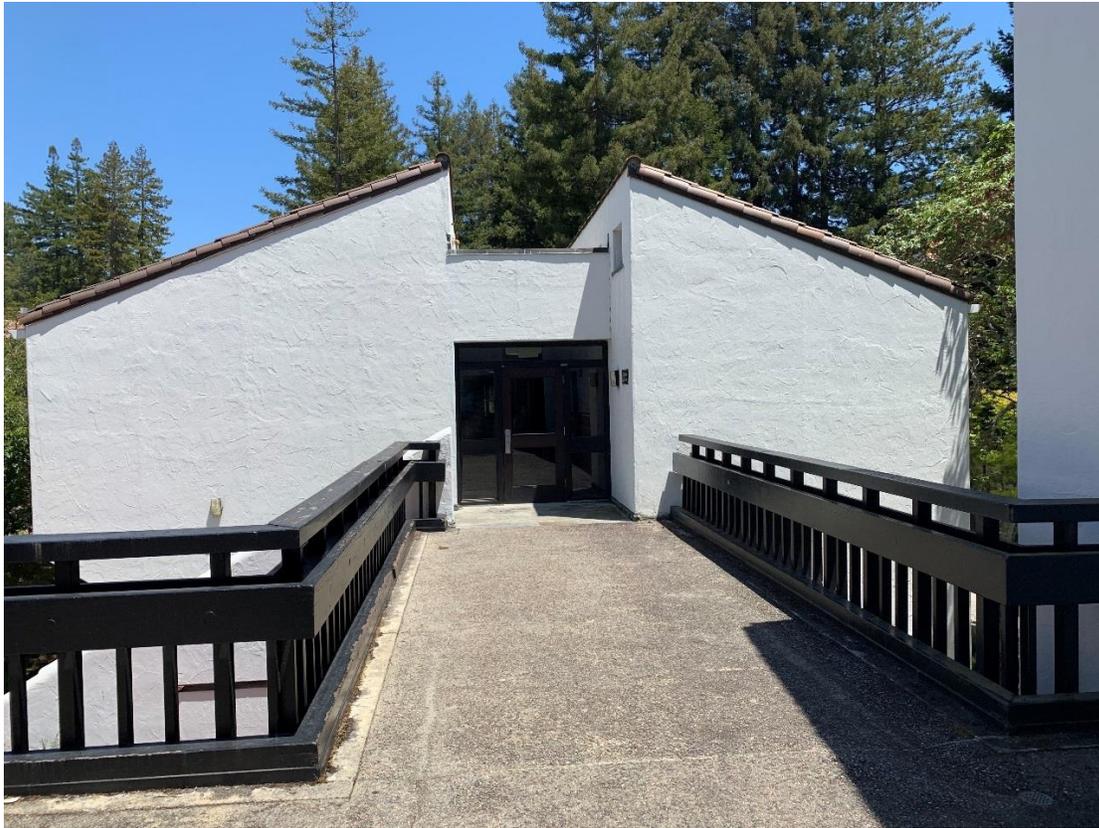
South Elevation (Showing Interface Between 1967 and 1985 Construction)
