MAFFEI STRUCTURAL ENGINEERING
maffe-structure.com
Dom Campi, Joe Maffei

UC Santa Cruz building seismic ratings
Jack Baskin Engineering

CAAN #7194
606 Engineering Loop, Santa Cruz, CA 95064
UCSC Campus: **Main Campus**

DATE: 2018-12-27

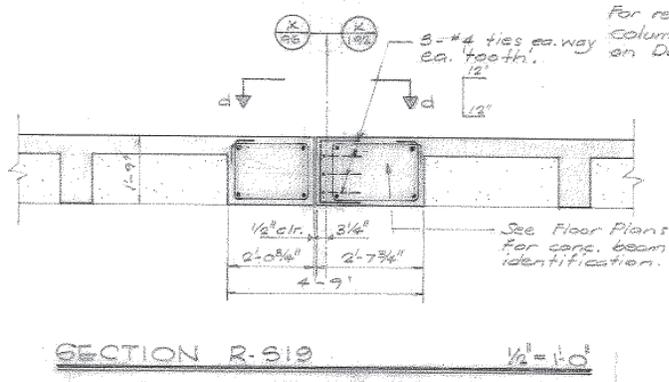
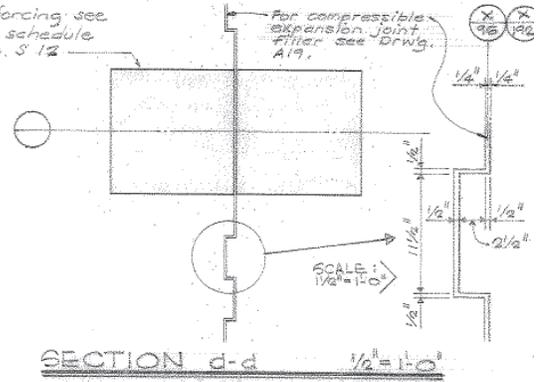
Section at separation joint/key

The waffle slab at each level serves as the floor diaphragm to deliver inertial story forces to the perimeter frame. As previously discussed, the diaphragm is separated into 3 parts by toothed expansion joints. The tothing of the diaphragm consists of 2-1/2" wide by 12-inch-long by full height keys. There is no reinforcement crossing the joints, including diaphragm chords.

We recommend that the University perform a more detailed evaluation as a precursor to probable structural retrofit. Partial retrofit to provide chord ties across separation joints, at roof level at a minimum, should be considered if more extensive retrofit cannot be accomplished in a short time frame. The structure would benefit from a Tier 3 evaluation using nonlinear response-history analysis (NLRHA).

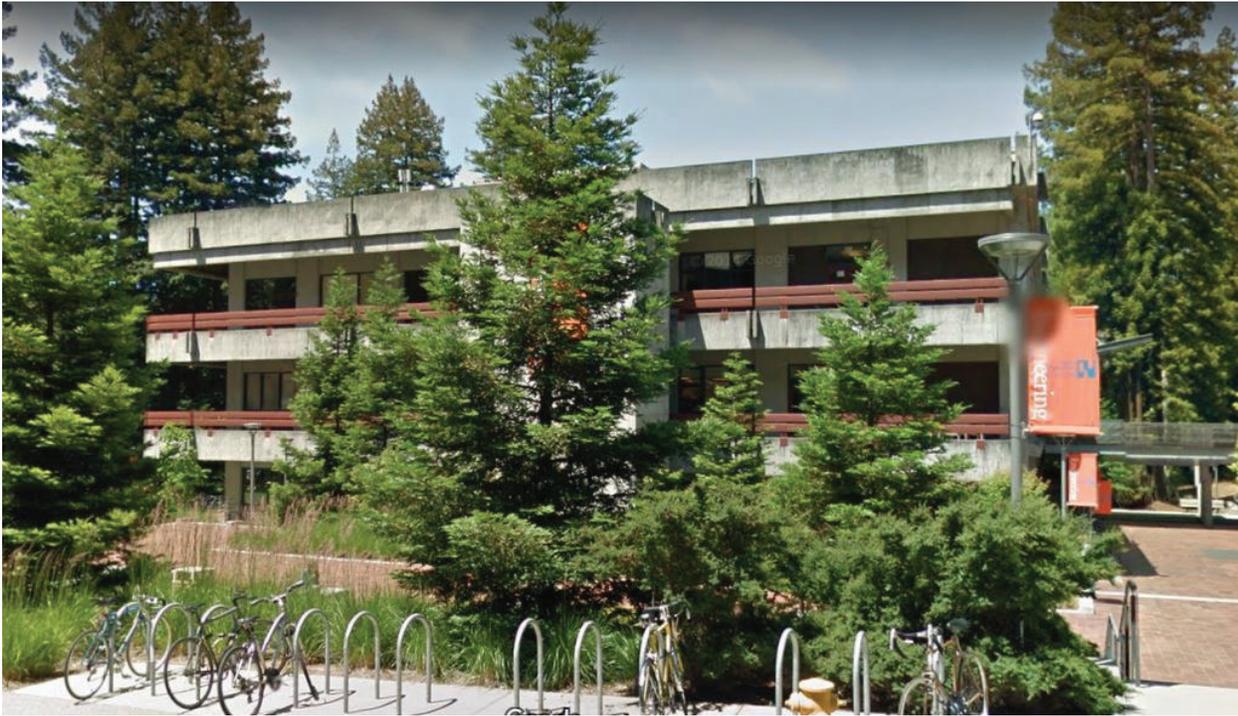
East elevation

- Frame columns on the east and west facades are heavily reinforced for flexure, and are flexure/ diagonal tension critical at the first level. Although the columns have closely spaced transverse reinforcement (#5 hoops plus #4 crosstie @ 4" o.c.) which are adequate to initially develop the column flexural strength, the shear strength of the column will degrade with moderate to high bending ductility demand leading to the possibility of shear failure as the building drifts. Similar concern exists at the square interior gravity columns at separation joints, which are flexure/ diagonal tension critical at all levels.

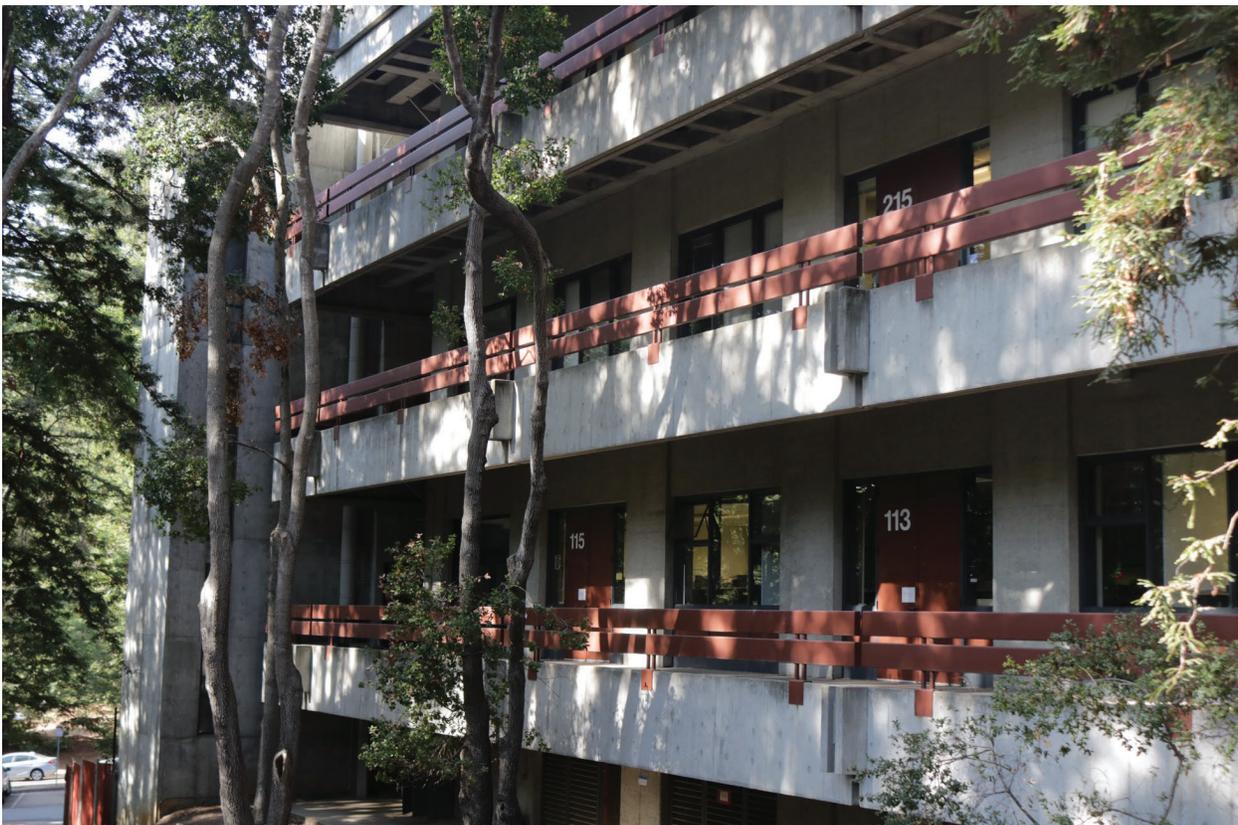
South elevation

- Frames on the north and south elevation do not satisfy strong column-weak beam test, substantially failing the test when only beam flexure behavior is assumed and failing to a lesser extent when beam shear failure is considered. This indicates a possibility of a story mechanism between the first and second floor levels and resulting increase in deformation demand.

- Frame beams on the north and south facades are strongly shear critical; these beams have less transverse reinforcement than the frame beams on the east and west facades.
