Rating form  
completed by:**MAFFEI STRUCTURAL ENGINEERING**

Dom Campi, Andreas Schellenberg, Joe  
MaffeiText in *green* is to be part of UC Santa Cruz building database and may be part of UCOP database**UC Santa Cruz building seismic ratings****Main Stage Theatre Arts (and Unit A)**

CAAN #7311 &amp; 7311.1

DATE: 2018-12-31

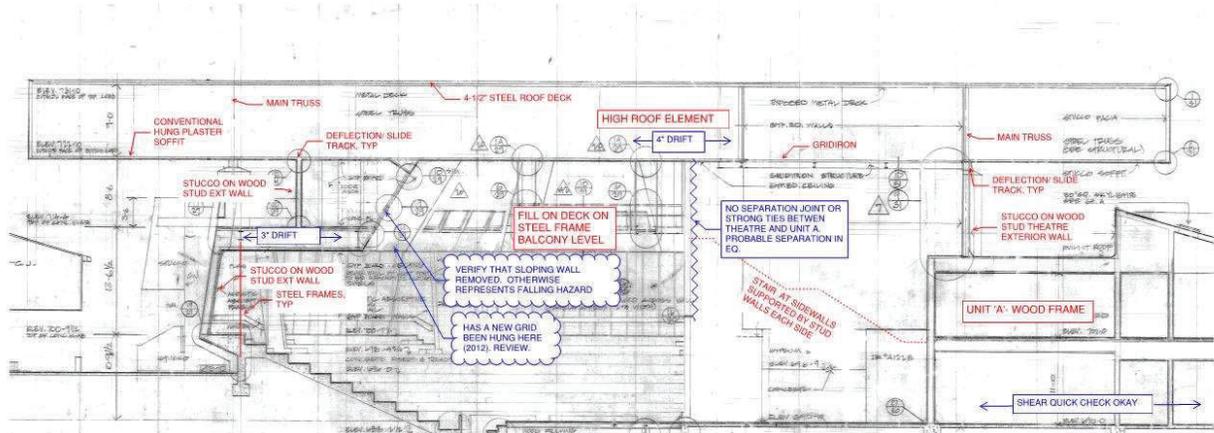
Figure 2: Annotated section (Theatre and Unit A)

The theatre has principal levels (refer to Figure 2 for a section through the building):
