UC Santa Cruz building seismic ratings
Theater Arts – 2nd Stage Annex

CAAN #7319
 449 Kerr Road
 UCSC Campus: **Main Campus**

DATE: 2019-06-30

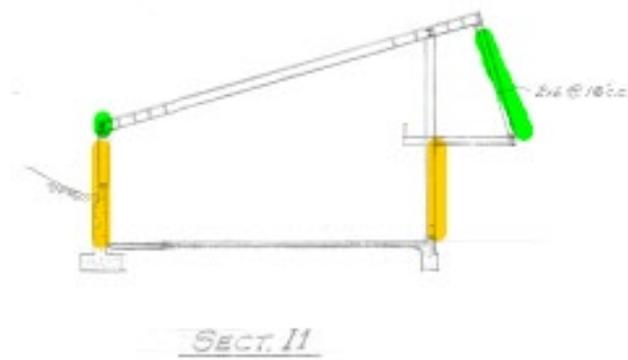
Building section (looking north)

- There is an out-of-plane setback in the front wall of the building, where the sloping near-vertical face of the roof bears on cantilevered steel beams, and does not align with the exterior walls below. We recommend that this condition be evaluated for adequacy, for instance with a Tier 2 analysis.

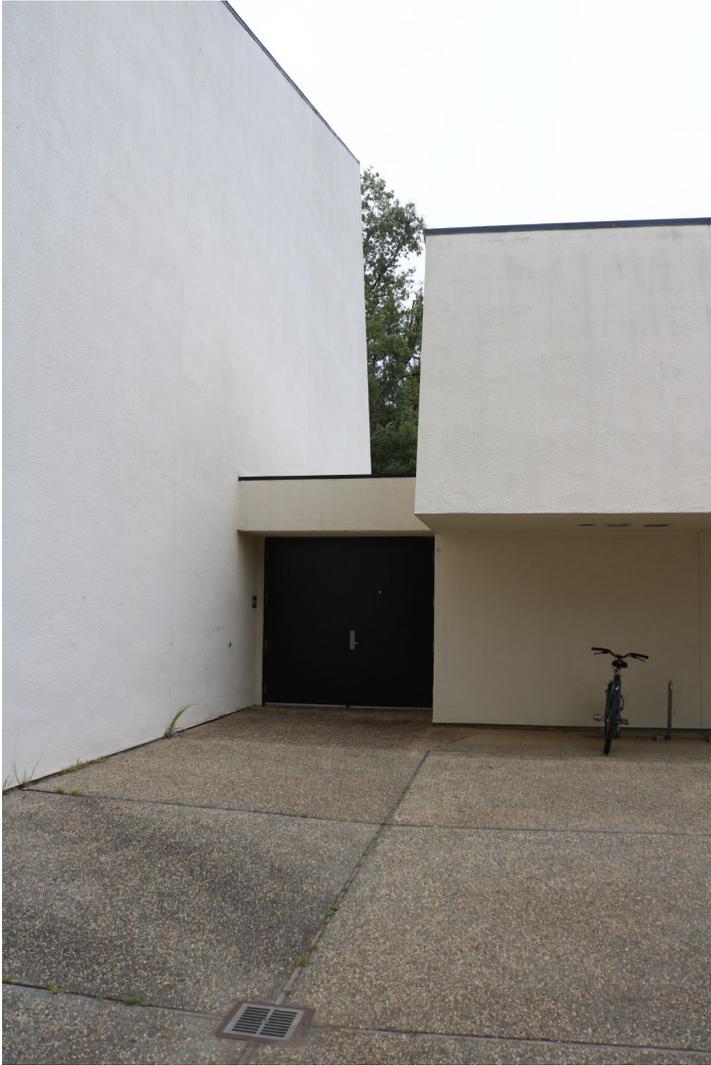
West elevation at corridor structure

- A corridor structure is attached to the north side of this building and provides access to the 2nd Stage building. The corridor structure is one-story tall. Roof joists in the corridor structure span north-south, connected at one end to the wall of the 2nd Stage building and at the other end to the wall of the 2nd Stage Annex building, with no seismic separation joints at either end. The elevation of the corridor roof does not line up with the elevation of the floor of the adjoining buildings. Differential movement of the 2nd Stage and 2nd Stage Annex building in the north-south direction may result in pulling the roof joists away from their supports, creating a falling hazard.

We walked through the building and we looked for potentially hazardous nonstructural components during our site visit on 13 June 2019. As shown in the table below, no non-structural hazards were observed inside the building. The corridor structure outside the building is a potential life safety concern, because it is connected to both the 2nd Stage and the 2nd Stage Annex buildings, with no seismic separation joints.

We recommend that the Campus perform a more detailed review of the connection of the corridor structure and consider providing separation joints in the corridor roof between buildings.
