Rating form completed by: **MAFFEI STRUCTURAL ENGINEERING**  
 maffei-structure.com  
 Adrian Ku (TSE), Noelle Yuen

DATE: 2019-06-30

**UC Santa Cruz building seismic ratings**  
**Oakes Academic Building**

CAAN #7416  
 233 Oakes Road  
 UCSC Campus: Main Campus

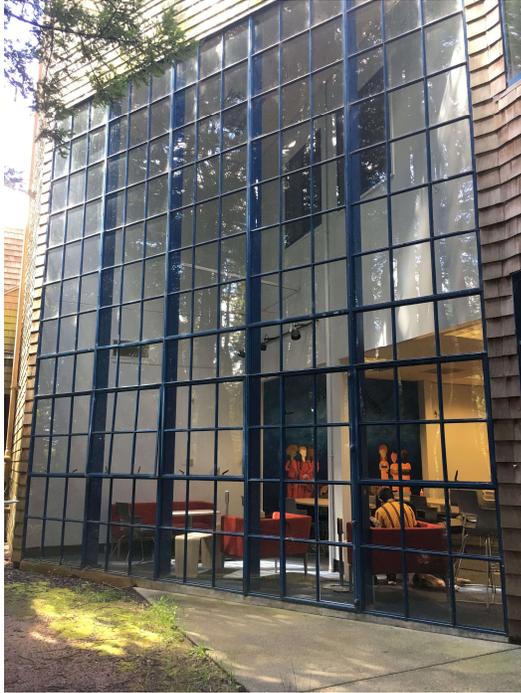
### Windows at study hall

- Above the main entrance doors there are large pendant lights. It is unknown what their connection to the ceilings are and may present a falling hazard in a seismic event.
- Sloping glass over the entry, may be susceptible to breaking because of excessive building movement. Overhead panels appear to be wired glass which may limit the safety concerns because of this falling hazard.
- Within the main entrance building study hall there were large multi-story, single pane windows. These large windows did not appear to be detailed to accommodate lateral drift or have a protective film in case of cracking and may present a falling hazard in a seismic event. Panels are attached to slender secondary framing elements which are in turn attached to the main frame, which may not provide adequate stiffness to protect the glazing.

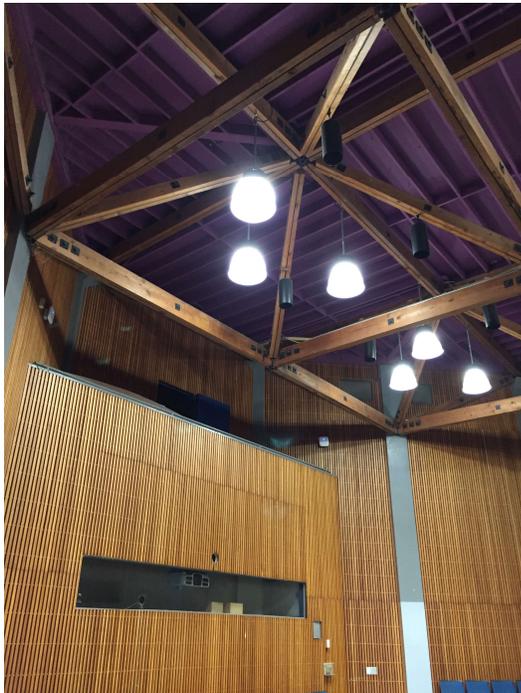
### Lecture hall roof framing

The lecture hall roof consists of 1/2" plywood supported by 2x8 joists at 16" on center. The joists are supported by a wood framed space truss system spanning over the hall. The trusses are composed of double 3x12 chords with double 3x8 diagonals, joined together by a steel pipe and shear tab assembly.
