UC Santa Cruz building seismic ratings
Oakes College Tutorial Commons

CAAN #7419
 249 Oakes Field Service Road, Santa Cruz, CA 95064
 UCSC Campus: Main Campus

DATE: 2019-06-30

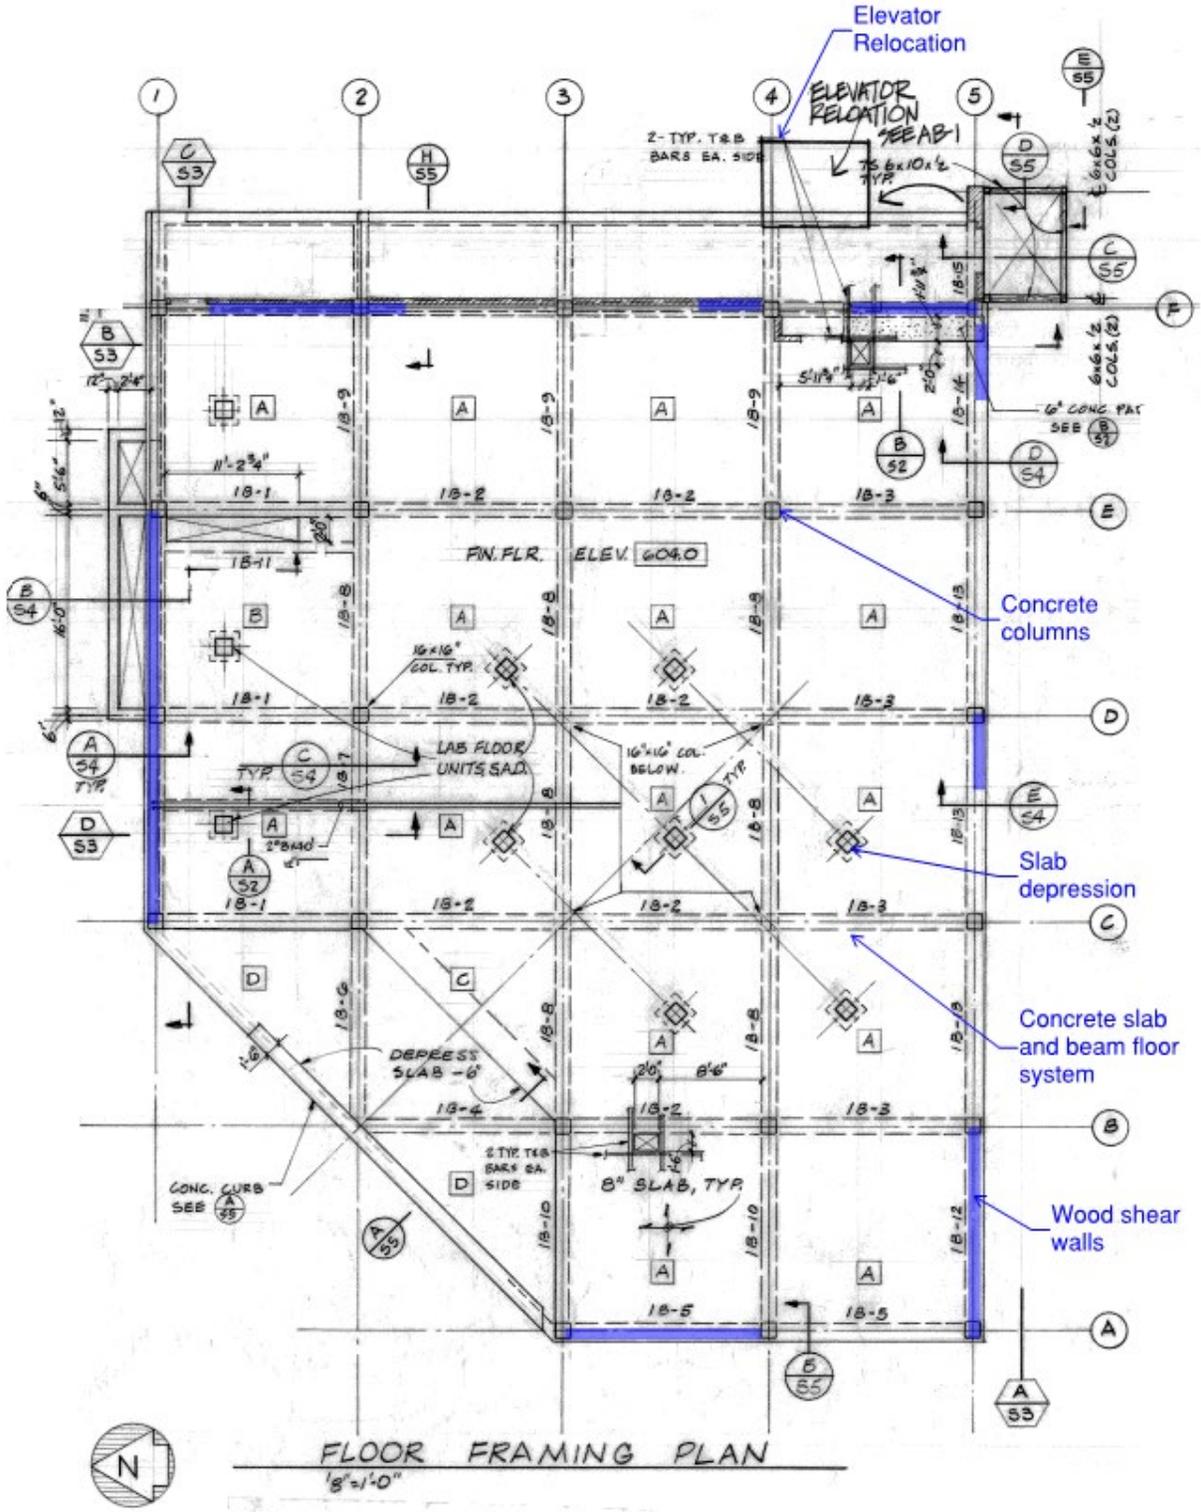
Annotated Level 2 Plan:

- The shear wall aspect ratios do not meet the Tier 1 checklist requirements, but the stress check shows that these walls are adequate.
- At Level 1 we expect plan torsion because of the wall placement and the large open area on the south and west side. We expect the inter-story drift and stress in the concrete shear walls at this level to be low because of the amount of wall, and we expect that the torsion response will be acceptable.

At L01 the continuous walls at the North and East face combined with the opening on the South and West will create torsion, but we expect drifts and the wall stress to be low

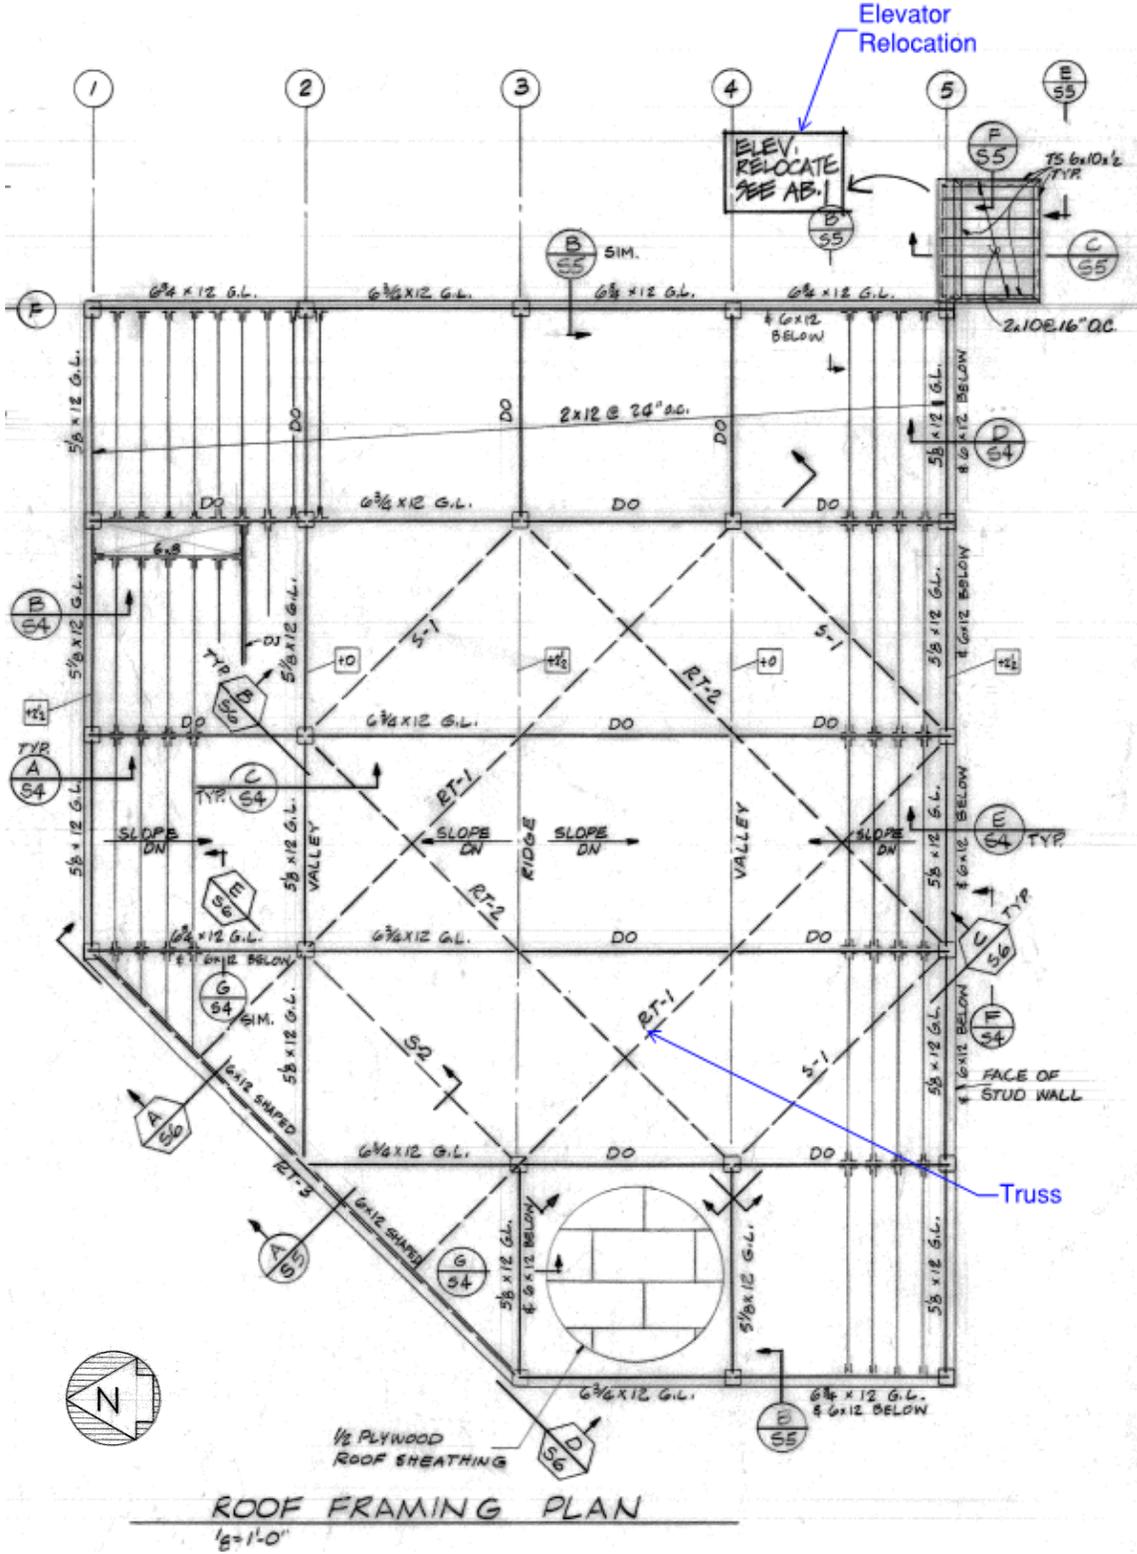
Annotated Roof Plan:

- The shear walls do not have hold-downs detailed in the drawings. Where shear walls interface with concrete columns, the walls are attached up the vertical face of the column with anchor bolts that will behave like hold-downs. For some of the smaller walls on the east and south, they do not interact with the concrete columns on both sides, but they still have anchor bolts and will be partially resisted by the glulam beams at the roof for uplift. Thus we believe that performance will be acceptable even if hold-downs are lacking.

Although we rate the building as IV (Fair), if there is remodeling of any walls, we recommend that the Campus consider adding hold-downs at wall ends where the might be lacking.

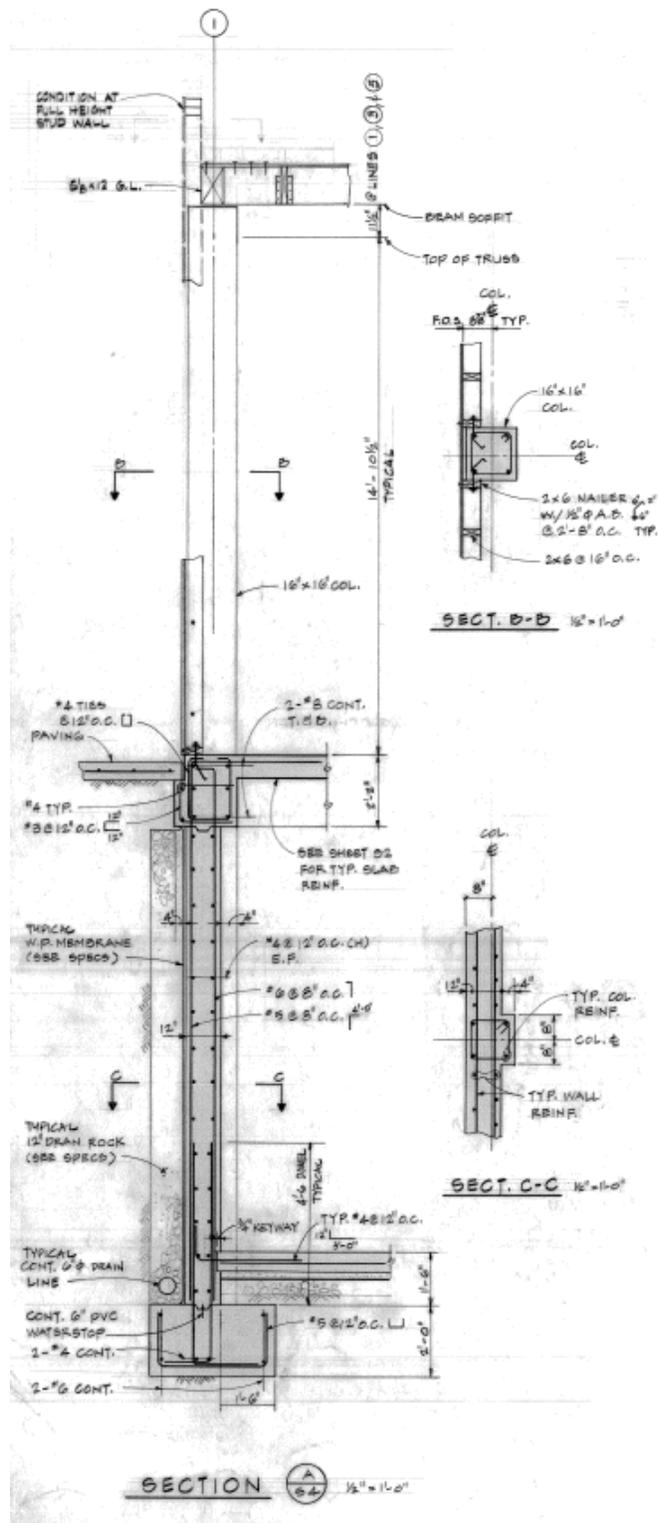
Wood shear wall over concrete shear wall typical detail:

Drawings do not callout hold downs. At some locations the wood walls are connected to columns which will behave like a hold down.
