**UC Santa Cruz building seismic ratings**  
**Visual Arts Facilities-Building C**

CAAN #7495

433 Baskin Arts Service Road, Santa Cruz, CA 95064

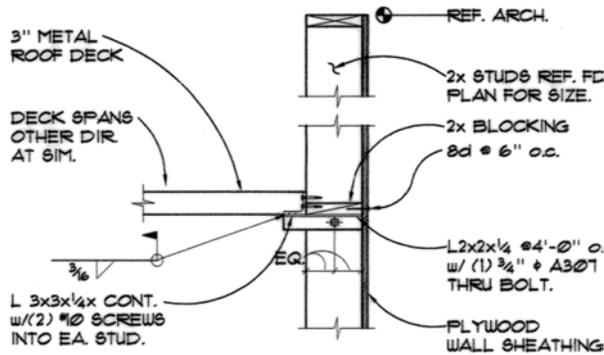
16 TYP. METAL  
ROOF DECK TO 2X STUDS  
1"=1'-0" S122

Metal Deck to Perimeter Roof-to-Wall Tie in Addition  
Detail 16/S303 is the Typical Condition; Detail 17/S303 is the Connection from the Addition  
(on the Right) to the Original Building (on the Left)

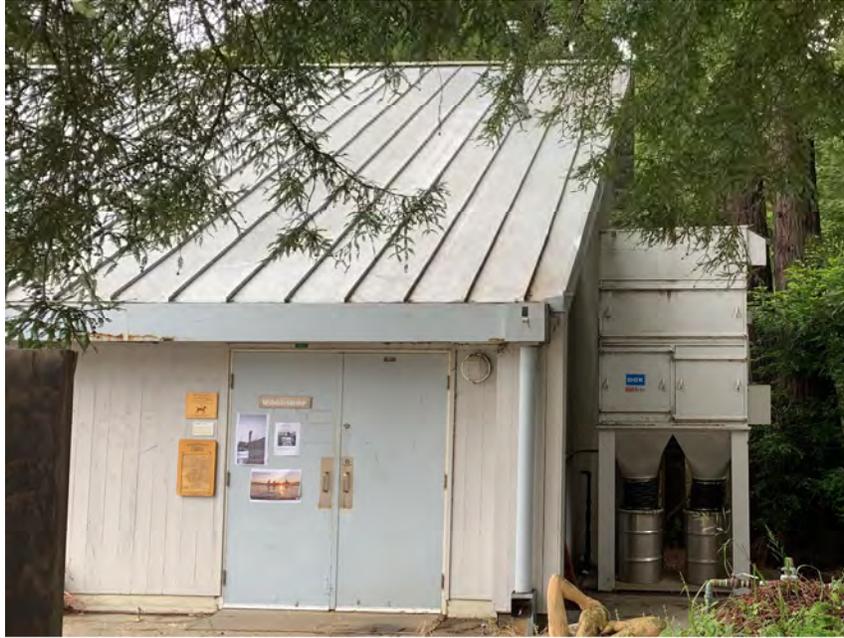
A dust collector was observed standing close to the east exterior wall of the building and is self-anchored into the concrete pad below; however, due to its weight and configuration, deflection of the unit under earthquake loading may need to be limited to avoid pounding damage to the exterior wall of Building C. Two basement rooms were not observed during the site visit and are therefore excluded from the scope of the nonstructural review.

The Dust Collector near the East Wall (Looking North)

We recommend that the campus perform a Tier 2 evaluation to review the lateral force-resisting capacity of the wood braced frame members, internal connections, and connections to the plywood shear wall. While ductility is low, it may be that there is sufficient capacity due to low demands. If the braced frames were found to be inadequate, connections could be strengthened or supplemental lateral resistance could be added, such steel moment frames to help continue to preserve the clerestory light. We assign the building to Priority Category B, as the retrofit of the building should be done when there are any plans for modifying or change of occupancy. Deflection of the duct collector under extreme seismic event should be limited to avoid pounding.

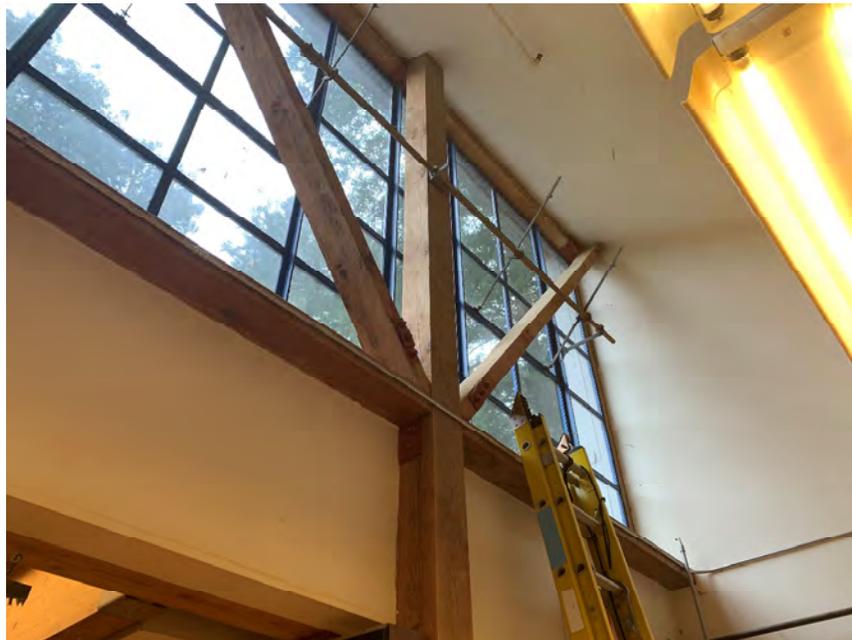
- The braced frames rely on a complicated set of force transfer details that include bolts in shear in the wood. These details have reduced end distances (4D rather than 7D) and limited ductility compared to a plywood shear wall that dissipates energy through nails in bending, and they are ultimately likely to lead to longitudinal splitting of the wood. This is an unusual structural system not covered by the wood frame Tier 1 checklists of ASCE 41-17. A Tier 2 deficiency-based analysis of the frames, their internal connections, and their connections to the shear walls is needed to understand better the capacity and performance of this lateral force-resisting system.
- Possible damage to the 2x rim joist at the floor level in the original drawing due to cross-grain bending.

Wood Braced Frame (Looking Northeast)
