UC Santa Cruz building seismic ratings

Hahn/McHenry Library Pedestrian Bridge

DATE: 2018-12-31

CAAN #7689A

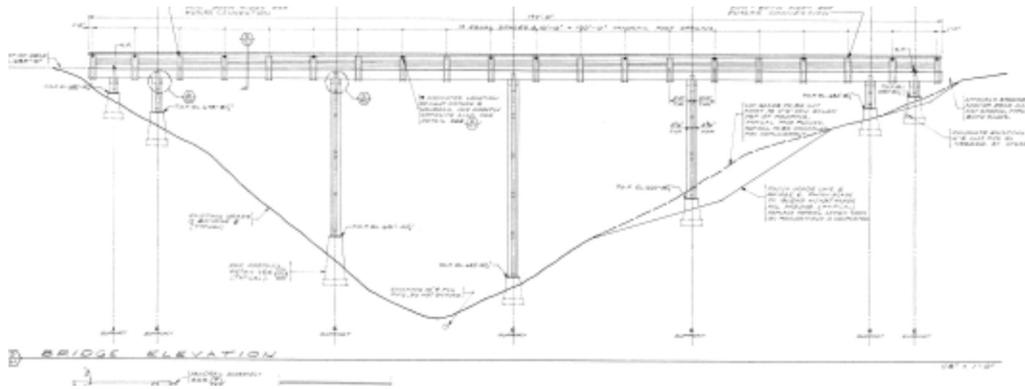
Figure: Bridge elevation

- The bridge does not appear to have a lateral-force-resisting system in the longitudinal direction, and the ability of the bridge to bear against the abutments for lateral seismic loads in its longitudinal direction is unclear from the drawings. The end members of the bridge that will bear against the abutment in an earthquake should be inspected in the field, and analyzed to determine if they have adequate strength.

We recommend that the University perform a more detailed seismic evaluation to determine whether retrofitting is required. Although the bridge was retrofitted in 2003, there were no calculations available to determine the criteria used for the retrofit, nor did the General Notes on the retrofit construction drawings indicate the criteria used for design. A linear dynamic analysis may be appropriate, including calculations to determine the adequacy of the heavy-timber braced frame vertical elements and their anchorage to the pedestal at their base. Applicable retrofit measures may include improving the anchor bolts of the braced frames for force or deformation capacity in the transverse direction, providing reliable bearing of the bridge at the abutments for lateral resistance in the longitudinal direction, strengthening the splice detail at the glulam girders, and providing additional bolts to stitch together the vertical 8x8 posts in the braced frames.

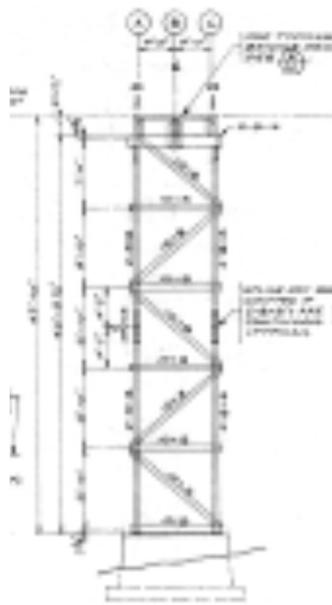
Figure: Elevation of bridge tower

- In the transverse direction, the piers have a high aspect ratio (maximum height of 50' and width of 8'), thus leading to high overturning demands on the pier vertical legs and on the anchor bolts at the base of the tower. Preliminary calculations show that the capacity of the bridge for transverse lateral forces is controlled by the strength of these elements. Initial Tier 1 Quick Check calculations show that the demand-to-capacity ratio of the vertical members is approximately 1.0 in the 25' high pier. The anchor bolts should be inspected in the field, and analyzed to determine if they have adequate strength. The vertical legs of the tower consist of 8x8 posts stitched together at 8'-10" o.c. with bolted connections; additional calculations are required to determine whether the posts are stitched together adequately, and the connections should be inspected in the field.

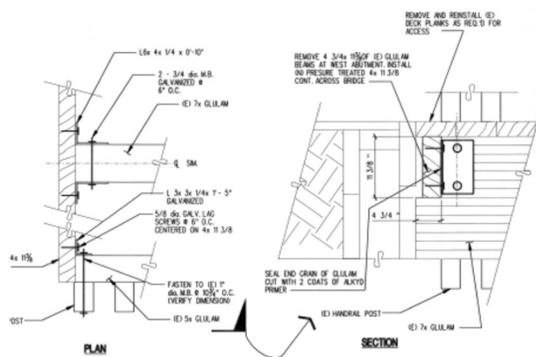
WEST ABUTMENT GLULAM REPAIR DETAIL
 SCALE: 1/12" = 1'-0"

In the longitudinal direction the lateral-force-resisting system is unclear. Timber buttresses retain soil and act as abutments at each of end of the bridge. We believe they are not connected to the bridge, and we have not inspected if there is space between these abutments and the end of the bridge. The 2003 seismic corrections replaced the transverse end timber of the bridge in the vicinity of the abutments.
