DATE: 2019-06-28

UC Santa Cruz building seismic ratings
Visual Arts Facilities-Building H

CAAN #7784

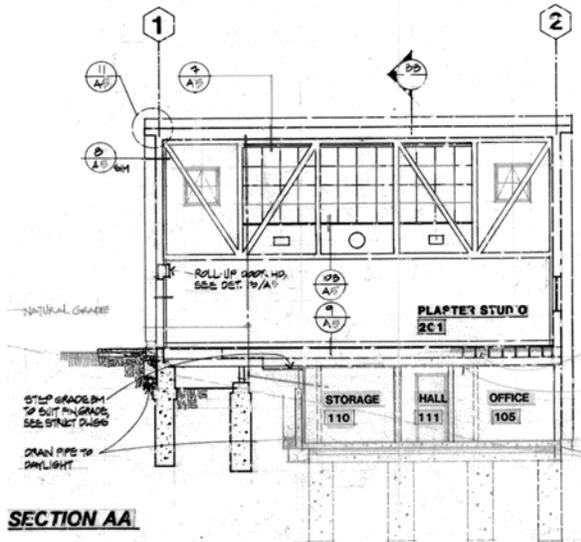
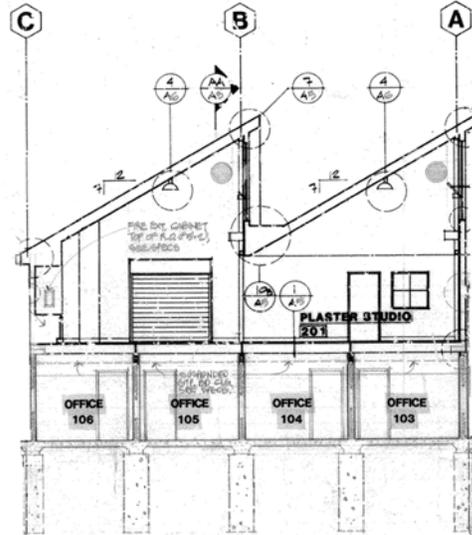
- For north-south loads, out-of-plane transfer of loads from the top of the wall on Line C into the roof joists likely relies only on toe nails with limited capacity, but the joists run over the top plate.

Inelastic behavior will likely be distributed in the roof diaphragm and the wall and possibly at the Line C roof-to-wall connection. There could also be movement due to differential settlement and slope stability from the unbalanced load of the hillside site. Evaluation of slope stability is beyond the scope of the Tier 1 evaluation.

When the building is re-roofed, we recommend investigation of the Line C roof-to-wall connection and possible improvement for north-south out-of-plane loading if only toe nails are found between the joists and top plate.
