UC Santa Cruz building seismic ratings
Theater Arts – 2nd Stage Annex

CAAN #7319
 449 Kerr Road
 UCSC Campus: **Main Campus**

DATE: 2019-06-30

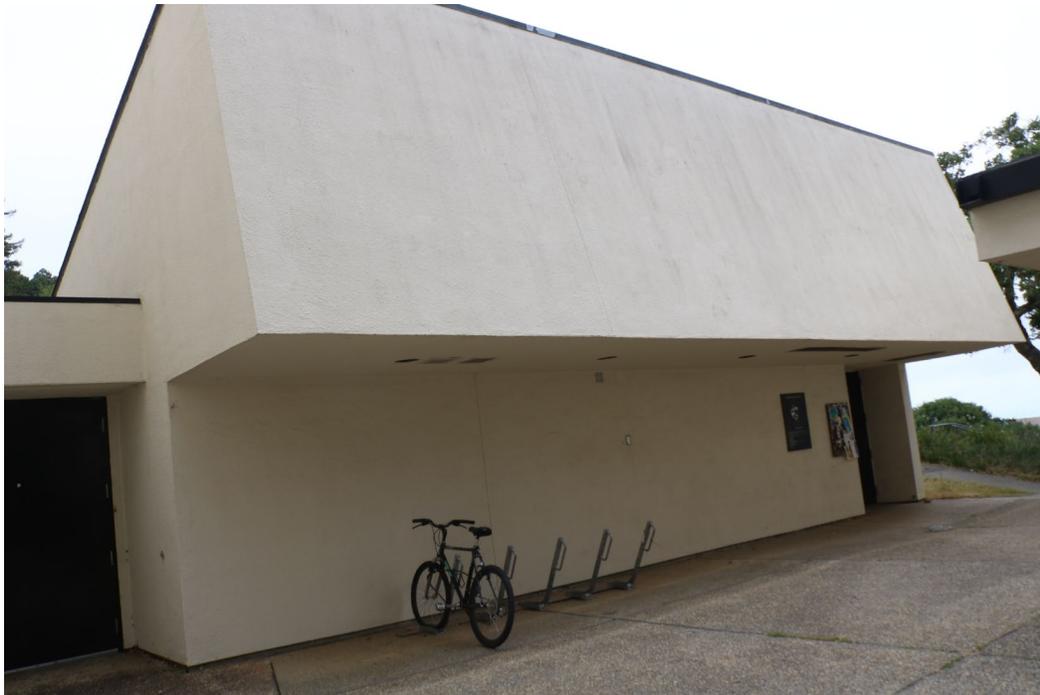
West elevation

The rating of V (Poor) is because of the potential life safety hazard posed by the corridor structure. The building itself could be rated IV (Fair) if the corridor is fixed.

We recommend that the Campus perform a more detailed review of the connection of the corridor structure and consider providing separation joints in the corridor roof between buildings.
