Rating form completed by: **MAFFEI STRUCTURAL ENGINEERING**  
 maffei-structure.com  
 Adrian Ku (TSE), Noelle Yuen

DATE: 2019-06-30

**UC Santa Cruz building seismic ratings**  
**Oakes Academic Building**

CAAN #7416  
 233 Oakes Road  
 UCSC Campus: Main Campus

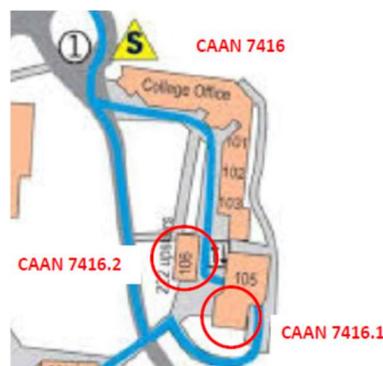
The Oakes Academic Building is at the Oakes College (formerly College 7) at the UCSC campus. The building was designed in 1974 by the architectural office of McCue, Boone and Tomsick and the structural office of Forell Elsesser. The building consists of six buildings separated by expansion joints. As shown in the layout plan below, for the purpose of this seismic evaluation, the buildings will be sub-divided into three CAANs as follows:

CAAN	Building Name
7416	Oakes Academic (consisting of north office wing, south office wing, entry hall, and lecture hall)
7416.1	Oakes Academic Lecture Hall addition
7416.2	Oakes Academic Graduate Student Annex
