**UC Santa Cruz building seismic ratings**  
**Visual Arts Facilities-Building C**

CAAN #7495

433 Baskin Arts Service Road, Santa Cruz, CA 95064

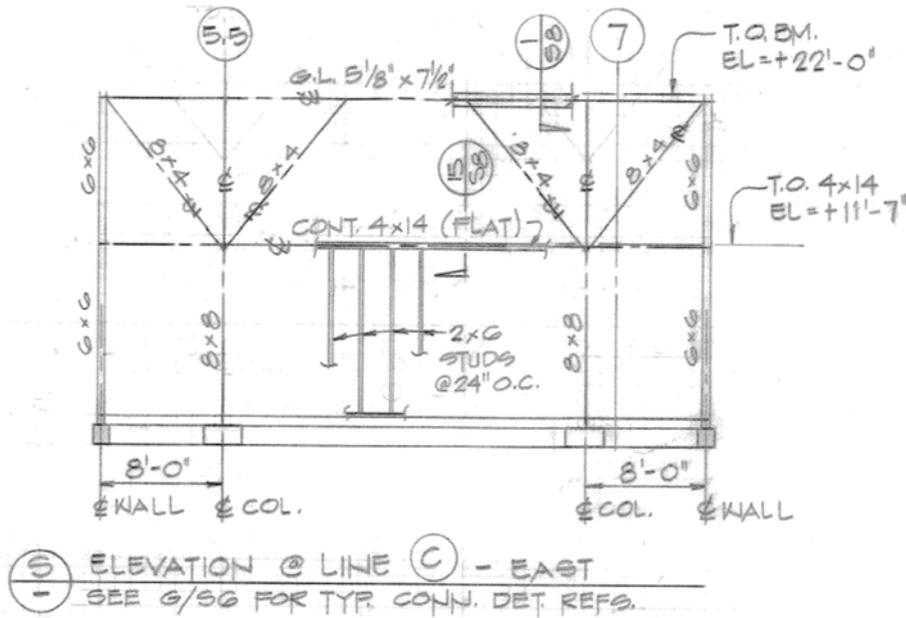
### Wood Brace Frame Elevation in the Existing Portion

- The braced frames rely on a complicated set of force transfer details that include bolts in shear in the wood. These details have reduced end distances (4D rather than 7D) and limited ductility compared to a plywood shear wall that dissipates energy through nails in bending, and they are ultimately likely to lead to longitudinal splitting of the wood. This is an unusual structural system not covered by the wood frame Tier 1 checklists of ASCE 41-17. A Tier 2 deficiency-based analysis of the frames, their internal connections, and their connections to the shear walls is needed to understand better the capacity and performance of this lateral force-resisting system.
- Possible damage to the 2x rim joist at the floor level in the original drawing due to cross-grain bending.

We recommend that the campus perform a Tier 2 evaluation to review the lateral force-resisting capacity of the wood braced frame members, internal connections, and connections to the plywood shear wall. While ductility is low, it may be that there is sufficient capacity due to low demands. If the braced frames were found to be inadequate, connections could be strengthened or supplemental lateral resistance could be added, such steel moment frames to help continue to preserve the clerestory light. We assign the building to Priority Category B, as the retrofit of the building should be done when there are any plans for modifying or change of occupancy. Deflection of the duct collector under extreme seismic event should be limited to avoid pounding.
